**PEUGEOT 3008: ZH4564**

**Limited Technical Inspection**

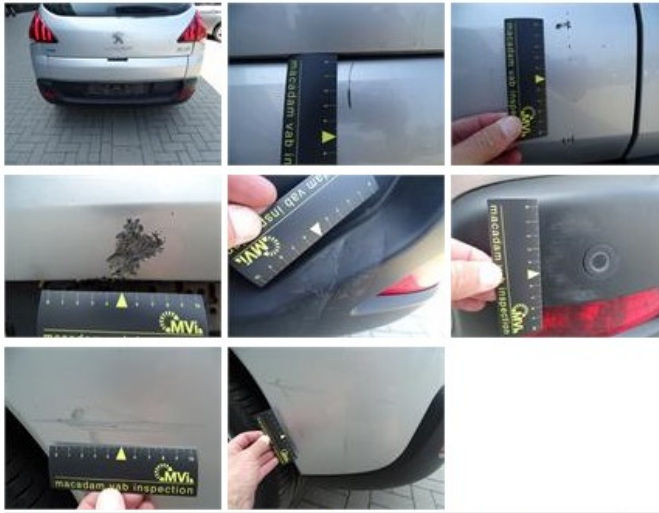
Bumper R, Damaged, LI - Repair and paint (complete)

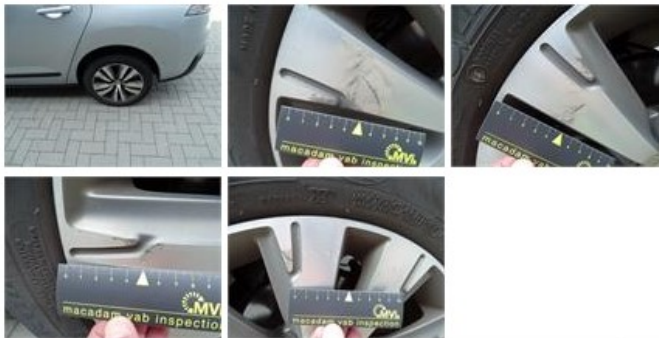
Alloy rim R L polished, Scratch(es), LI - Repair and paint (complete)
