**MERCEDES B: 1HDP239**

**Limited Technical Inspection**

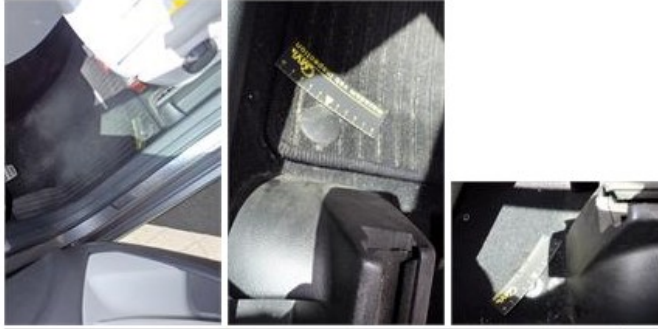
windscreen, Stone chip(s), Acceptable	0,00
<i>No pictures to display</i>	
Rear window, Scratch(es), Acceptable	0,00
<i>No pictures to display</i>	
Bonnet, Stone chip(s), Acceptable	0,00
<i>No pictures to display</i>	
Floor covering F L, Burned, Smart repair	64,32
