## VOLVO XC60: 1HEJ549

## Limited Technical Inspection

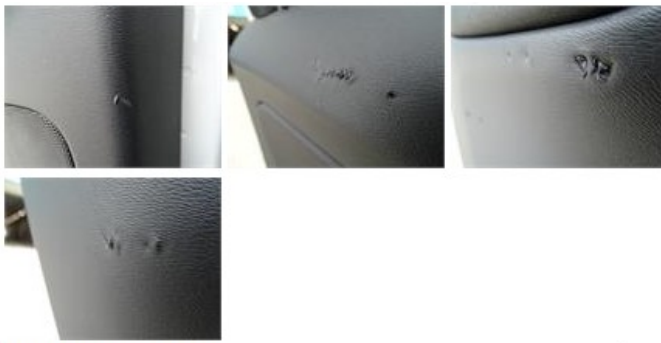
Door panel R L, Damaged, Smart repair	<b>110,64</b>
---------------------------------------	---------------

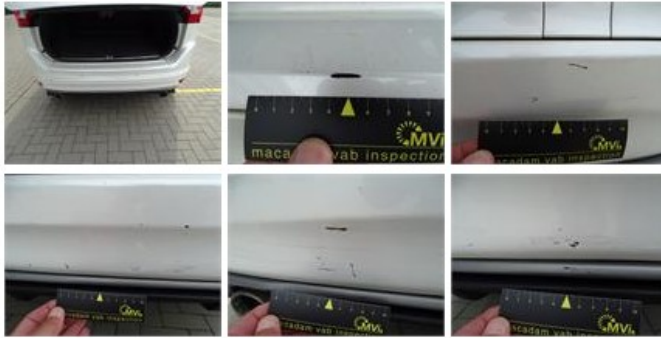
Bumper R, Scratch(es), LI - Repair and paint (complete) 254,16
