## VOLVO V60: 1GCS818

## Limited Technical Inspection

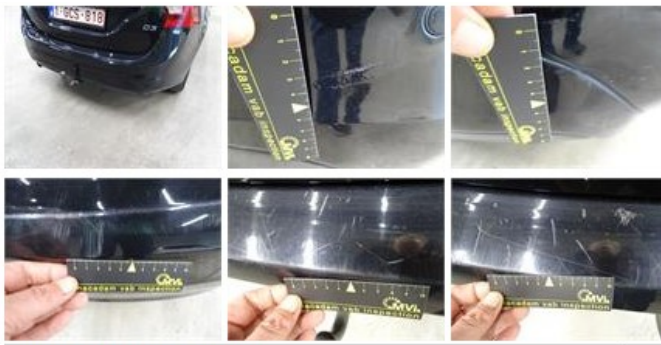
Bumper R, Scratch(es), LI - Repair and paint (complete)	211,80
---	--------

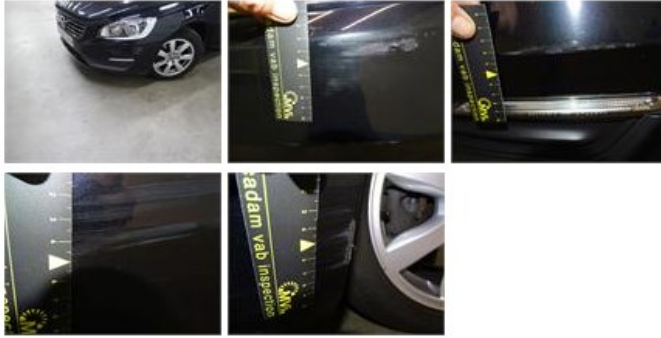
Front bumper, Scratch(es), LI - Repair and paint (complete) 211,80
