MERCEDES A: 1FGF696

Limited Technical Inspection

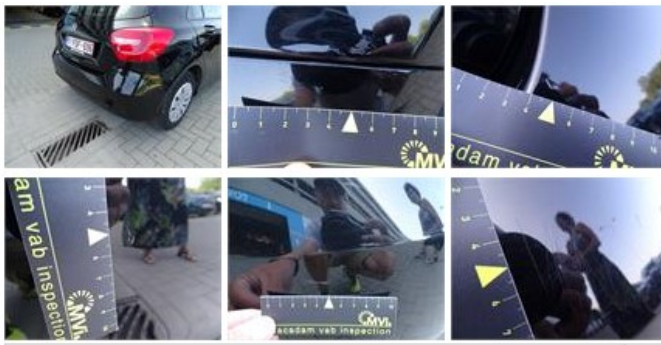
Bumper R, Bump(s) and scratch(es), LI - Repair and paint (complete)
211,80

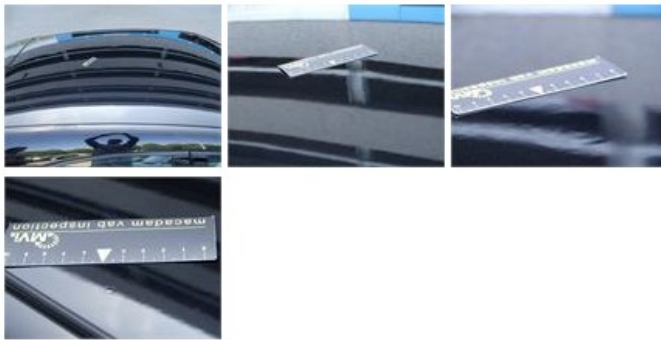
Roof, Bad repair, Paint 0,00
