**BMW 5: 132CCR**

**Limited Technical Inspection**

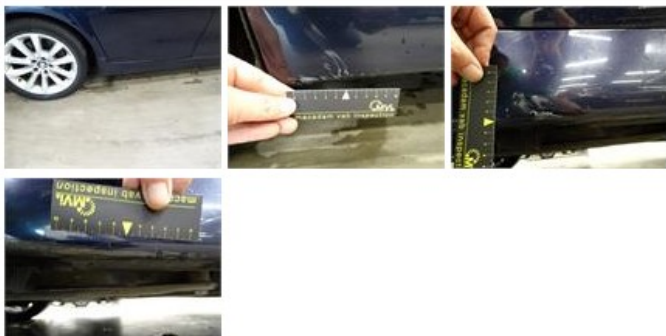
Total cost ex VAT	1500,89
Sill outer R, Scratch(es), LI - Repair and paint (complete)	372,60

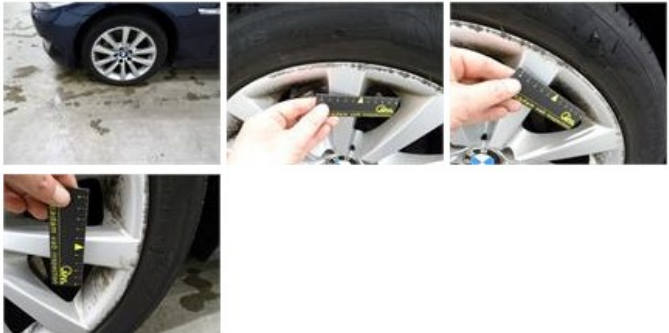
Wing F R, Repaired, Acceptable		0,00
<i>No pictures to display</i>		
Alloy rim F L, Scratch(es), LI - Repair and paint (complete)		95,00
