FORD KUGA: 1LDN529			
Vinnnumber:	<b>WFOAXXWPMFY82176</b>	Versionname:	<b>2.0 TDCI 2WD 88KW TREND</b>
First Registrationdate:	<b>28/08/2015</b>	Fiscalpower:	
Expertise Mileage:	<b>115153</b>	Power Kw:	<b>88</b>
Bodytype:	<b>SUV</b>	Body color:	<b>Black</b>
Gearbox:	<b>MAN 6 VIT</b>	Paint type:	<b>Metalic</b>
Transmission:		Rims summer:	<b>Aluminium</b>
Fueltype:	<b>Diesel</b>	Oil level:	<b>OK</b>
Battery functioning:	<b>Yes</b>	Parking lot:	<b>1606</b>
Number of doors:	<b>5</b>		
Number of seats:	<b>5</b>		
Number head rests:	<b>5</b>		
Rims summer:	<b>Aluminium</b>		
Category:	<b>Passenger Car</b>		
Oil level:	<b>OK</b>		
Registration Certificate Car (BE):	<b>Yes</b>

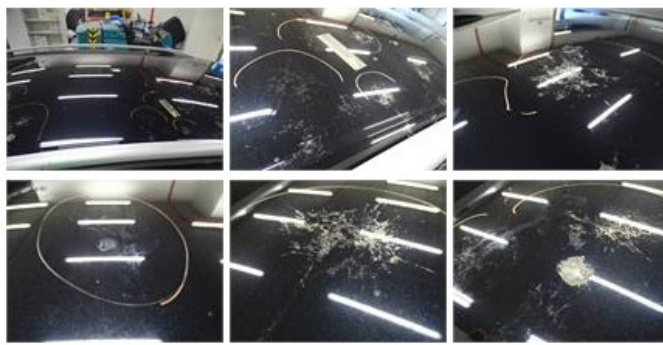
Roof, Chemical pollution, LI - Repair and paint (complete)	<b>0,00</b>
--	-------------

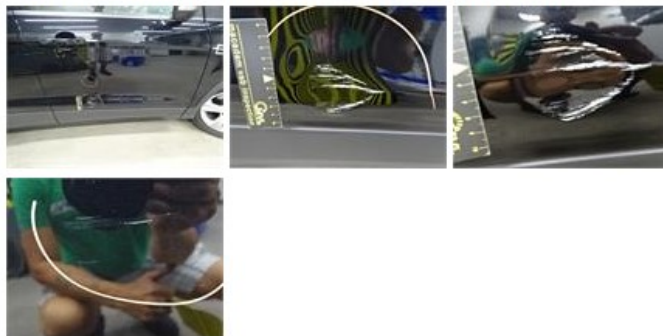
Door F R, Bump(s) and scratch(es), LI - Repair and paint (complete) 382,02

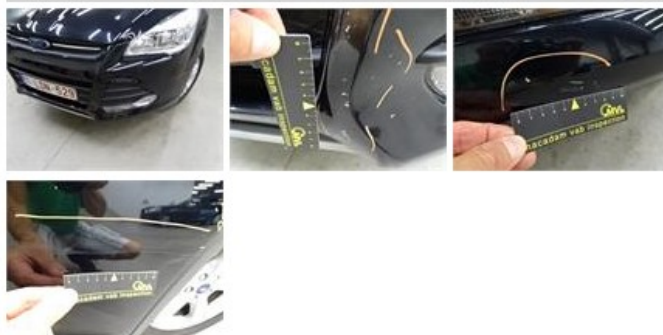
Front bumper, Scratch(es), LI - Repair and paint (complete) 254,16

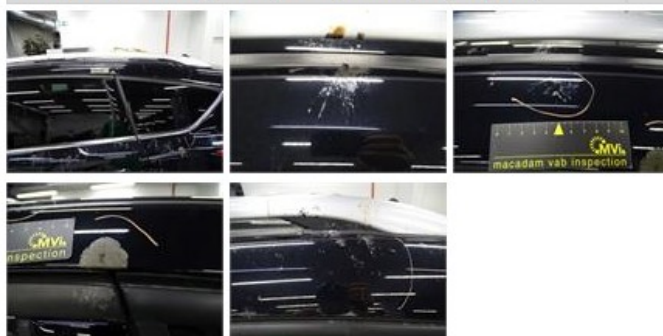
Roof pillar L, Chemical polution, LI - Repair and paint (complete) 264,22

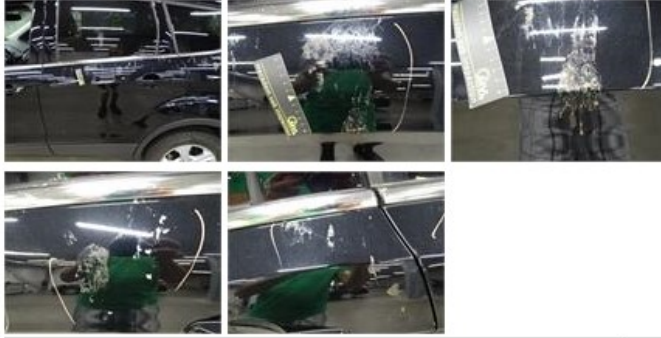
Door R L, Chemical polution, LI - Repair and paint (complete)

382,02
