**MERCEDES CLA: 1GUX282**

**Limited Technical Inspection**

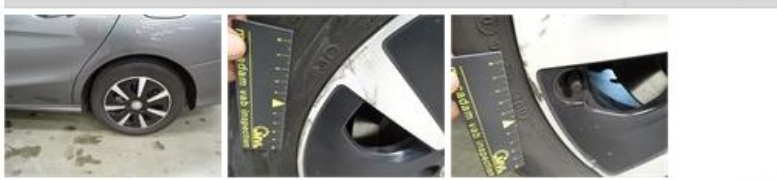
Alloy rim R L polished, Scratch(es), LI - Repair and paint (complete)	<b>95,00</b>
---	--------------
