RENAULT Clio: 1FKD783

Limited Technical Inspection

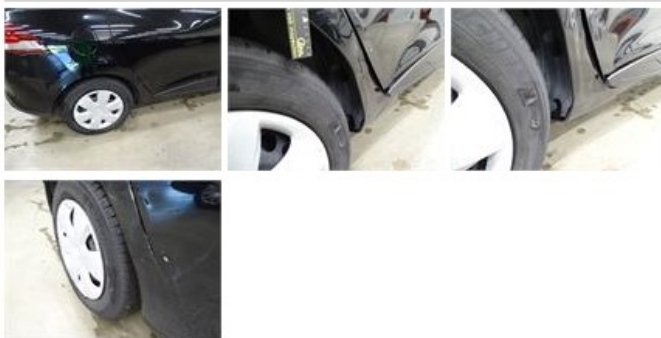
Wing R R, Bump(s) and scratch(es), Le - Replace and paint 1033,21
