OPEL Insignia: 1EKU185

Vinnumber:	W0LGM8EL5D1028606	Versionname:	INSIGNIA BRE ecoFL.Edit.150ys DPF 130PK
First Registrationdate:	9/01/2013	Fiscalpower:	96
Expertise Mileage:	106666	Power Kw:	96
Bodytype:		Body color	Black
Gearbox:	MAN 6 VIT	Paint type	Metalic
Transmission:	Front	Rims summer	Steel
Fueltype:	Diesel	Oil level	OK
Maintenance	OK	Parking lot	4101
Battery functioning	Yes		
Number of doors	5		
Number of seats	5		
Number head rests	5		
Rims summer	Steel		
Category	Passenger Car		
Oil level	OK

Limited Technical Inspection

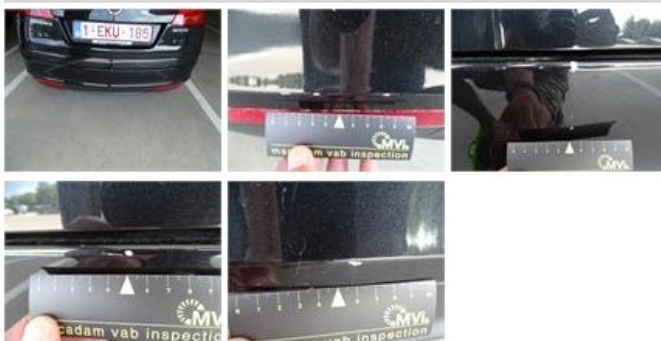
Bumper R, Scratch(es), LI - Repair and paint (complete) 211,80
