VOLKSWAGEN Crafter 35MWB: 1HKA429			
Vinnnumber:	WV1ZZZ2ZF6007822	Versionname:	CRAFTER 35 B/F2C MWB
First Registrationdate:	6/08/2014	Fiscalpower:	109PK
Expertise Mileage:	192292	Power Kw:	80
Bodytype:		Body color:	Grey
Gearbox:	MAN 6 VIT	Paint type:	Metalic
Transmission:	Front	Rims summer:	Steel
Fueltype:	Diesel	Oil level:	OK
Battery functioning:	Yes	Parking lot:	TRU13
Number of doors:	6		
Number of seats:	6		
Number head rests:	6		
Rims summer:	Steel		
Category:	Light Commercial Vehicle		
Oil level:	OK		
Registration Certificate Car (BE):	Yes

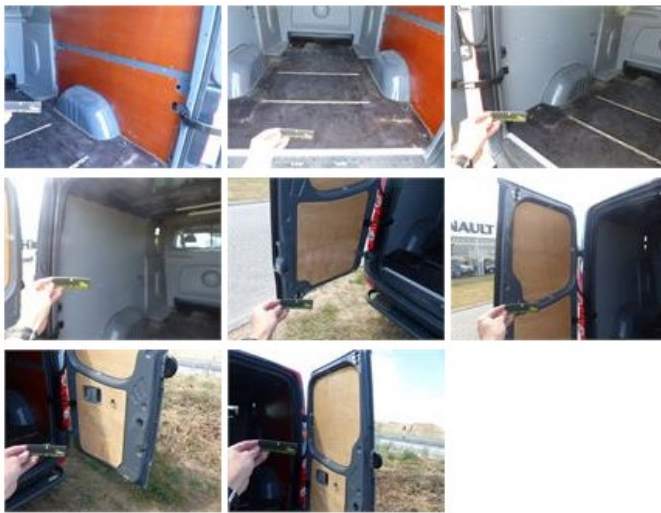
Interior, Damaged, Acceptable 0,00

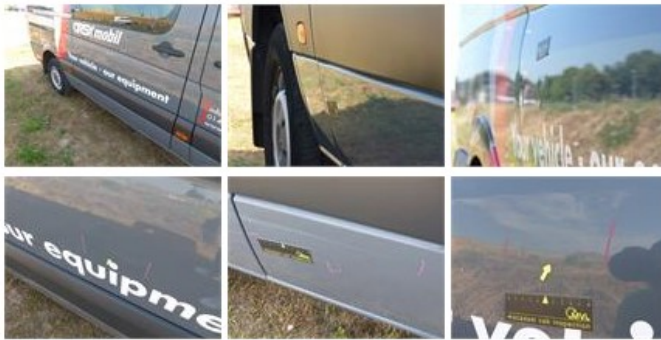
Sliding door R, Bump(s) and scratch(es), LI - Repair and paint (complete) 382,02

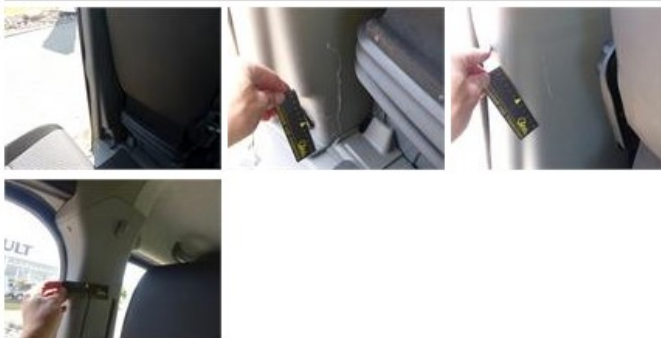
Covering mid pillar L, Scratch(es), Smart repair 110,64
