VOLKSWAGEN Golf: 1HBV875			
Vinnnumber:	WVWZZZAUZEW361046	Versionname:	GOLF BER Highline 105PK
First Registrationdate:	13/06/2014	Fiscalpower:	
Expertise Mileage:	179237	Power Kw:	77
Bodytype:		Body color:	Brown
Gearbox:	MAN 5 VIT	Paint type:	Metalic
Transmission:		Rims summer:	Aluminium
Fueltype:	Diesel	Oil level:	OK
Battery functioning:	Yes	Parking lot:	3308
Number of doors:	5		
Number of seats:	5		
Number head rests:	5		
Rims summer:	Aluminium		
Category:	Passenger Car		
Oil level:	OK		
Registration Certificate Car (BE):	Yes

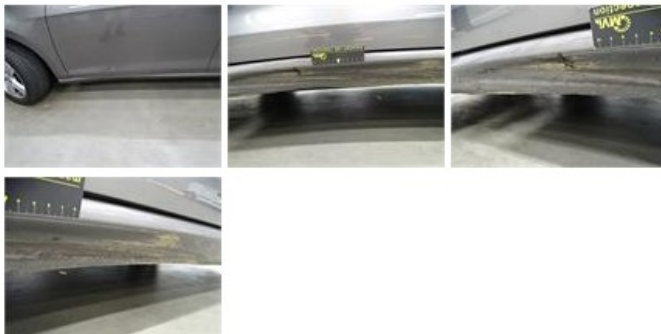
Total cost ex VAT	1950,98
Sill outer L, Bump(s) and scratch(es), Le - Replace and paint	712,00

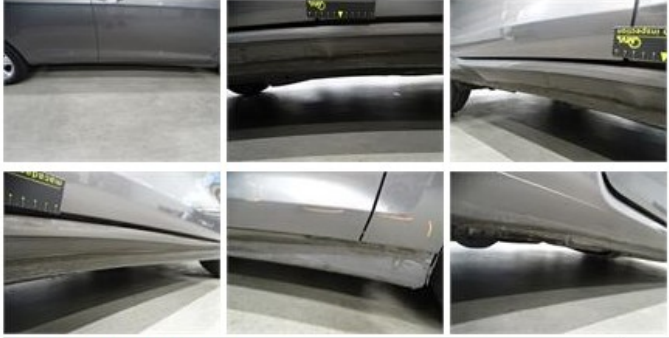
<i>No pictures to display</i>		
Sill outer R, Bump(s) and scratch(es), Le - Replace and paint		712,00

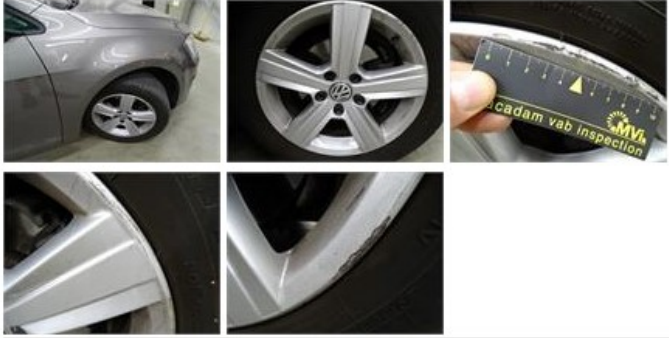
Bonnet, Bump(s), Acceptable		0,00
<i>No pictures to display</i>		
Alloy rim F R, Scratch(es), LI - Repair and paint (complete)		95,00

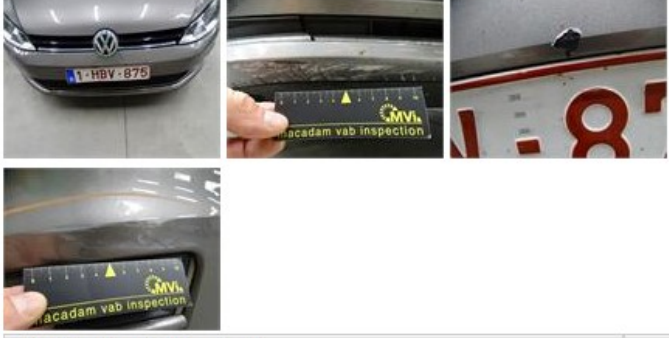
Wing R R, Bump(s), Acceptable		0,00
<i>No pictures to display</i>		
Front bumper, Scratch(es), LI - Repair and paint (complete)		211,80
