**TOYOTA AURIS: 1NEZ964**

**Limited Technical Inspection**

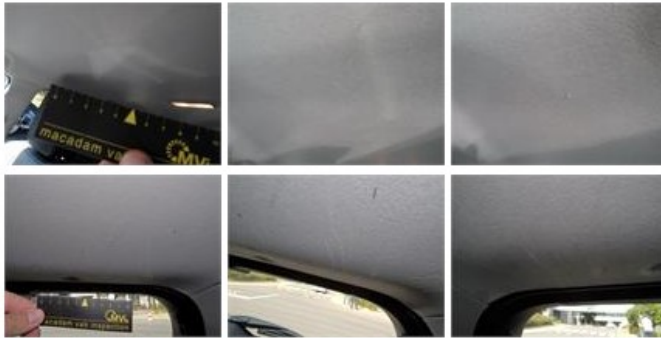
Ceiling, Scratch(es), Smart repair 64,32
