RENAULT Grand Scenic: 1FJG087

Limited Technical Inspection

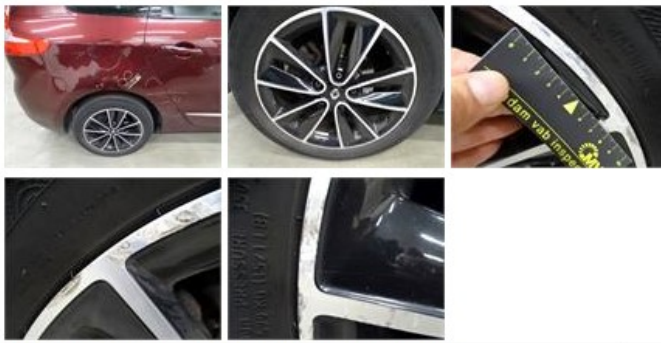
Alloy rim R R, Scratch(es), LI - Repair and paint (complete) 318,35

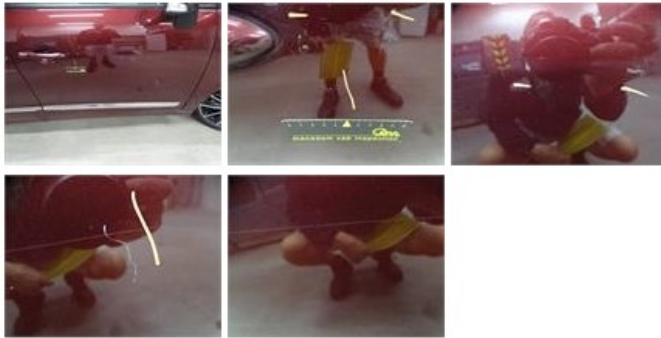
Door F R, Scratch(es), LI - Repair and paint (complete) 318,35

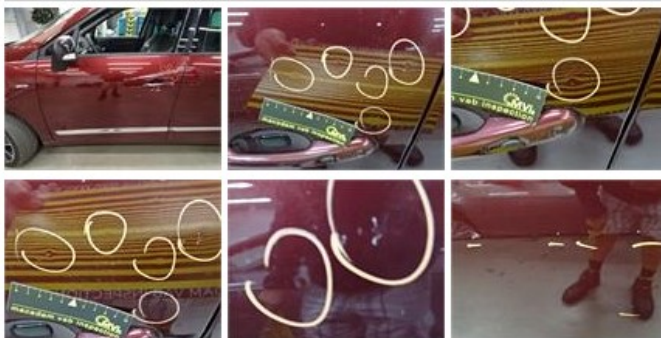
Door F L, Bump(s) and scratch(es), LI - Repair and paint (complete) 318,35
