BMW 1: 1HLZ999

Limited Technical Inspection

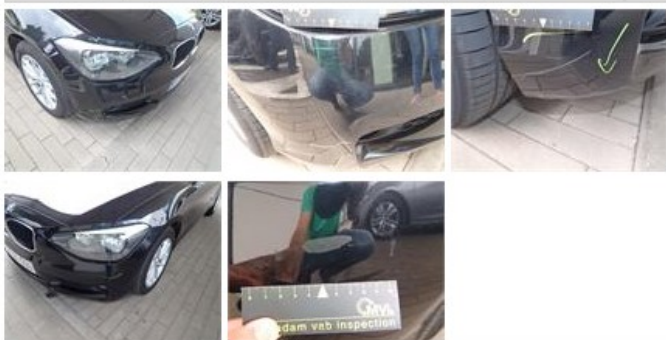
Front bumper, Scratch(es), LI - Repair and paint (complete)	211,80
--	---------------

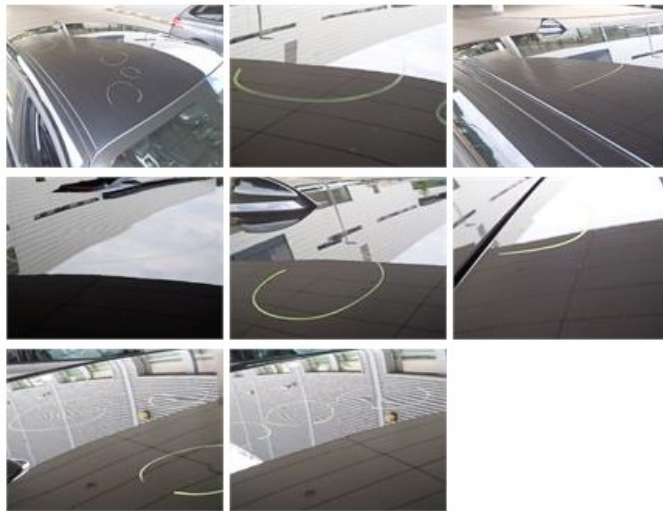
Roof, Bump(s), LI - Repair and paint (complete) 481,50

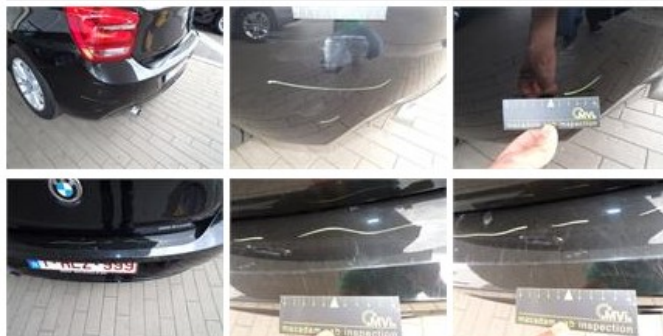
Bumper R, Scratch(es), LI - Repair and paint (complete) 211,80

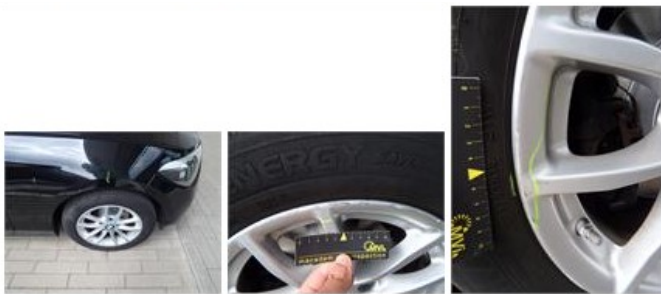
Alloy rim F R, Scratch(es), LI - Repair and paint (complete) 95,00
