**BMW 3: 1FXG444**

**Limited Technical Inspection**

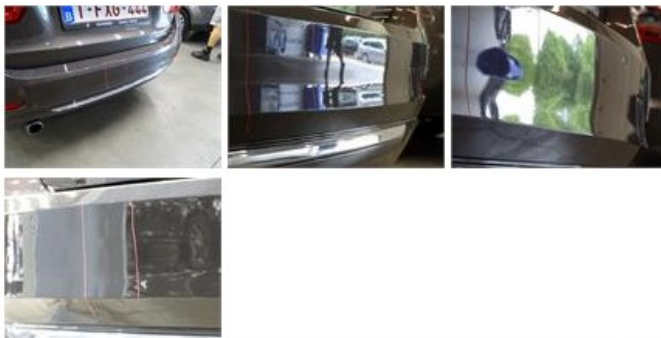
Bumper R, Bump(s), LI - Repair and paint (complete)	<b>283,80</b>
---	---------------

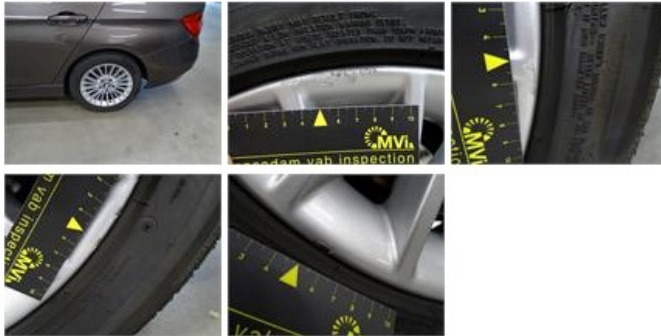
Alloy rim R L, Scratch(es), LI - Repair and paint (complete) 95,00

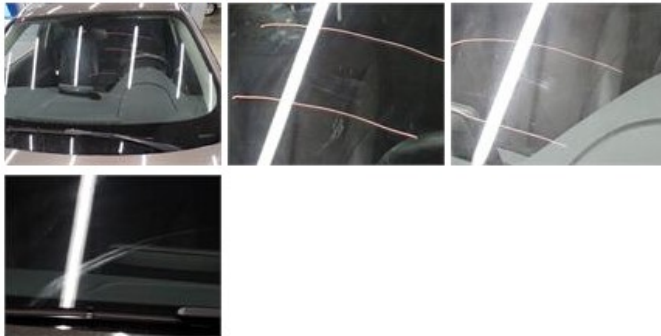
Windscreen, Scratch(es), E - Replace 0,00

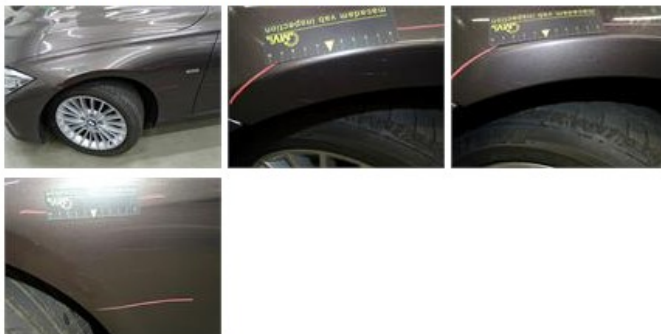
Wing F L, Scratch(es), LI - Repair and paint (complete) 220,18
