<b>BMW 5: HA9231</b>			
Vinnnumber:	<b>WBA5K71030D802314</b>	Versionname: <b>5 TOURING 535dAX 313PK Aut.</b>	
First Registrationdate:	<b>8/12/2015</b>	Fiscalpower:	
Expertise Mileage:	<b>172976</b>	Power Kw:	<b>230</b>
Bodytype:	<b>Break</b>	Body color:	<b>Dark Brown</b>
Gearbox:	<b>Automatic</b>	Paint type:	<b>Metalic</b>
Transmission:		Rims summer:	<b>Aluminium</b>
Fueltype:	<b>Diesel</b>	Oil level:	<b>OK</b>
Battery functioning:	<b>Yes</b>	Parking lot:	<b>2424</b>
Number of doors:	<b>5</b>		
Number of seats:	<b>5</b>		
Number head rests:	<b>5</b>		
Rims summer:	<b>Aluminium</b>		
Category:	<b>Passenger Car</b>		
Oil level:	<b>OK</b>

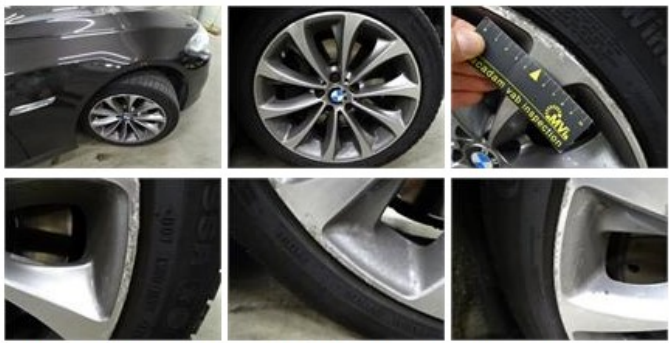
<b>Assistance equipment</b>	
	Runflat <b>Yes</b>
Total cost ex VAT	512,80
Alloy rim F R polished, Scratch(es), LI - Repair and paint (complete)	95,00

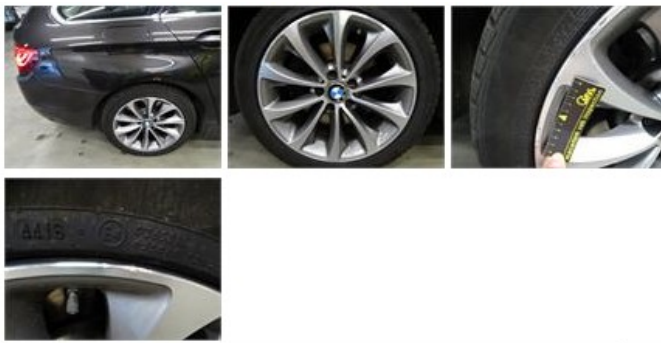
Alloy rim R R polished, Scratch(es), LI - Repair and paint (complete)	95,00
---	-------

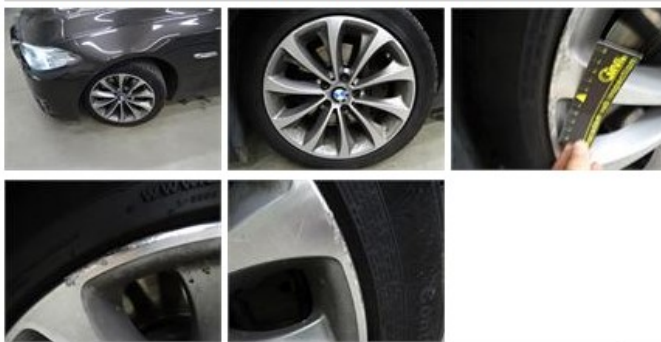
Alloy rim F L polished, Scratch(es), LI - Repair and paint (complete) 95,00

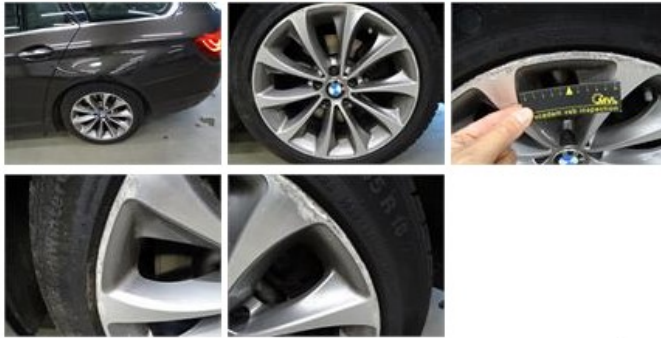
Alloy rim R L polished, Scratch(es), LI - Repair and paint (complete) 95,00

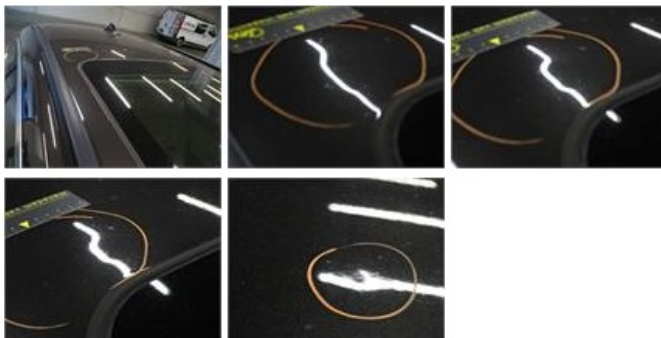
Roof, Bump(s), PDR - Knock out without painting 82,80
