## CITROEN C4 Picasso: 1ANV743

## Limited Technical Inspection

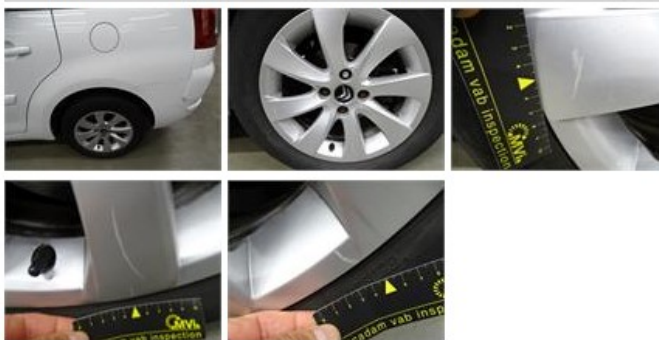
Total cost ex VAT	671,24
Alloy rim R R, Scratch(es), Acceptable	0,00
<i>No pictures to display</i>	
Alloy rim R L, Scratch(es), LI - Repair and paint (complete)	95,00

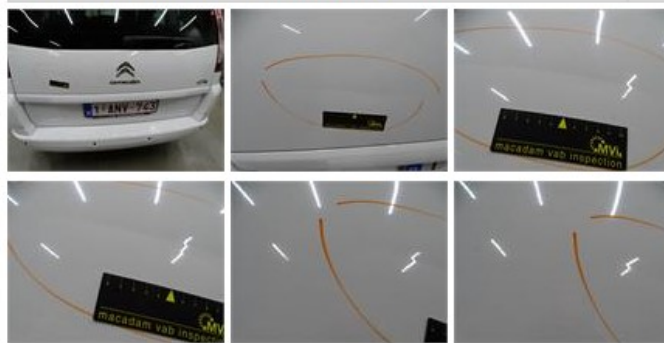
Tailgate, Bump(s), LI - Repair and paint (complete) 301,68

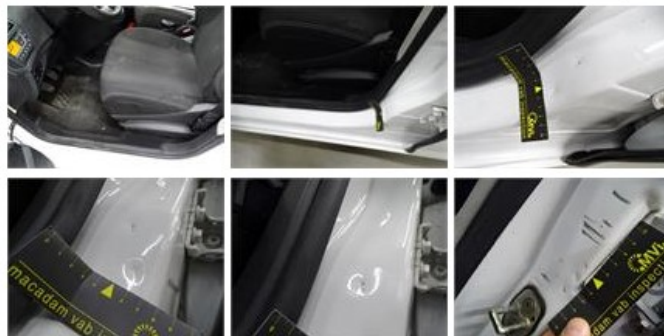
Rocker panel inner F L, Bump(s) and scratch(es), LI - Repair and paint (complete) 115,56

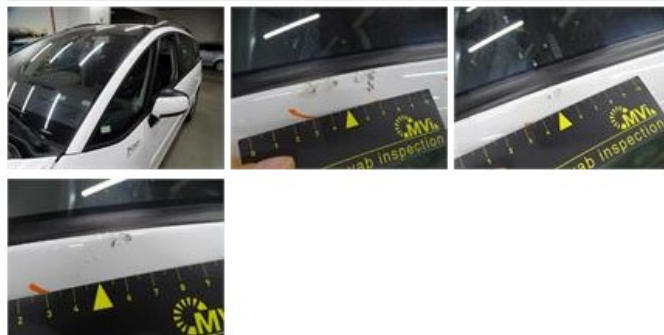
Roof pillar L, Rust, Acceptable 0,00
