**MERCEDES B: 1HGK236**

**Limited Technical Inspection**

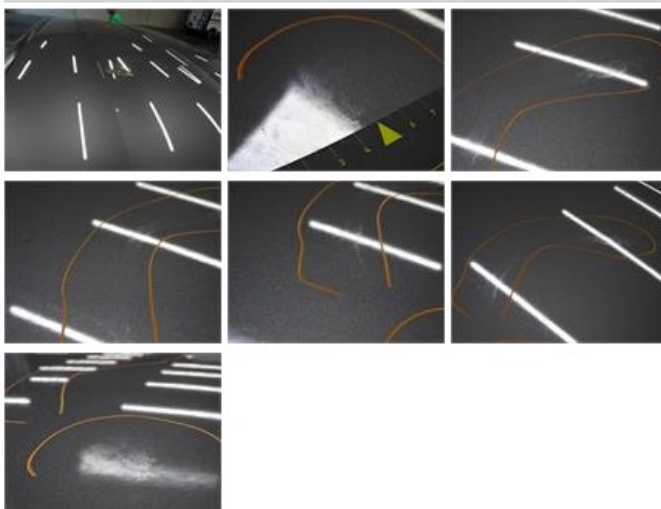
Roof, Chemical polution, LI - Repair and paint (complete)

481,50

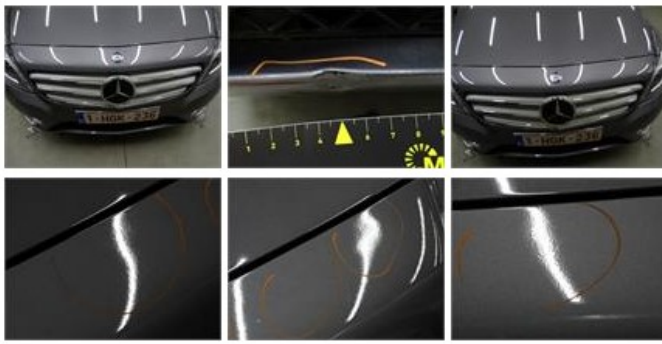
Front bumper, Bump(s) and scratch(es), LI - Repair and paint (complete)

211,80
