MERCEDES CLA SHOOTING BRAKE: 1KHE782

Limited Technical Inspection

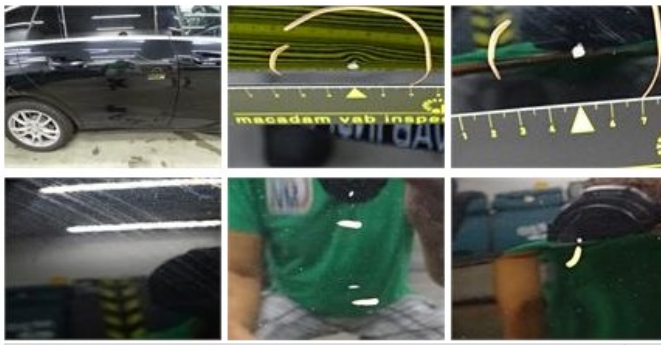
Door R R, Bump(s) and scratch(es), LI - Repair and paint (complete)	318,35
---	--------
