MERCEDES C: 1GKJ787

Vinnnumber:	WDD2042021G296653	Versionname:	C BRE 220CDI BE Edition Avantgarde 163PK
First Registrationdate:	3/03/2014	Fiscalpower:	
Expertise Mileage:	97813	Power Kw:	120
Bodytype:		Body color:	Blue
Gearbox:	MAN 6 VIT	Paint type:	Metalic
Transmission:	Back	Rims summer:	Aluminium
Fueltype:	Diesel	Oil level:	OK
Maintenance:	NOT OK	Parking lot:	2101
Battery functioning:	Yes		
Number of doors:	5		
Number of seats:	5		
Number head rests:	5		
Rims summer:	Aluminium		
Category:	Passenger Car		
Oil level:	OK		
Registration Certificate Car (BE):	Yes

Limited Technical Inspection

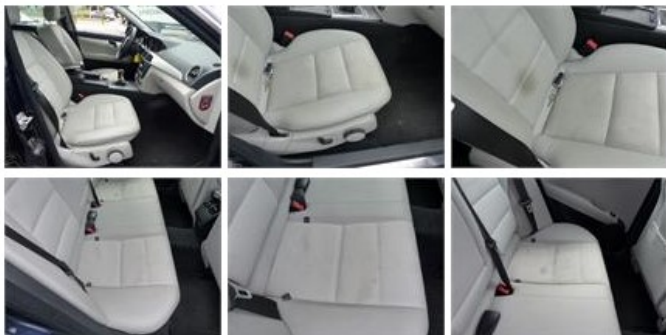
Interior, Stain, Cleaning **100,00**

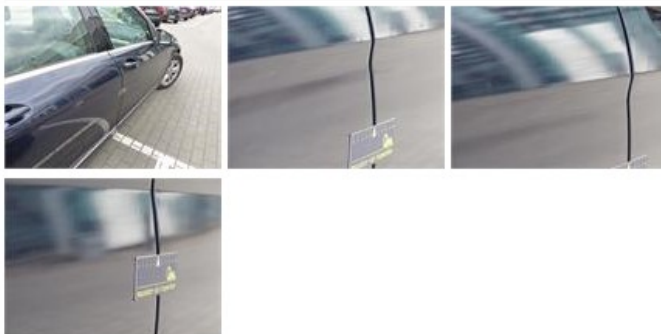
Door R R, Bad repair, Acceptable 0,00

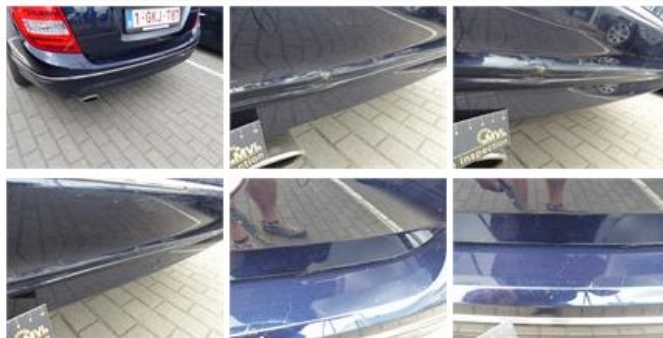
Bumper R, Bump(s) and scratch(es), LI - Repair and paint (complete)	259,80
---	--------
