SKODA Superb: 1GTA517			
Vinnumber:	<b>TMBJJ73T4E9044375</b>	Versionname:	<b>SUPERB COMBI Ambition 105PK</b>
First Registrationdate:	<b>22/04/2014</b>	Fiscalpower:	
Expertise Mileage:	<b>140132</b>	Power Kw:	<b>77</b>
Bodytype:	<b>Break</b>	Body color:	<b>Brown</b>
Gearbox:	<b>MAN 6 VIT</b>	Paint type:	<b>Metalic</b>
Transmission:		Rims summer:	<b>Aluminium</b>
Fueltype:	<b>Diesel</b>	Oil level:	<b>OK</b>
Battery functioning:	<b>Yes</b>	Parking lot:	<b>2833</b>
Number of doors:	<b>5</b>		
Number of seats:	<b>5</b>		
Number head rests:	<b>5</b>		
Rims summer:	<b>Aluminium</b>		
Category:	<b>Passenger Car</b>		
Oil level:	<b>OK</b>		
Registration Certificate Car (BE):	<b>Yes</b>

Limited Technical Inspection			
Airco functioning	<b>OK</b>	Battery functioning	<b>Yes</b>
Tires wear profile	<b>OK</b>	Power steering	<b>Yes</b>
Idle position	<b>OK</b>	Sound engine	<b>OK</b>
Engine startingtime	<b>OK</b>	Clutch test	<b>OK</b>
Exhaust gass	<b>OK</b>	Wiper fluid level	<b>OK</b>
Handbrake	<b>OK</b>	Transmission	<b>OK</b>
		Lighting	<b>OK</b>
		Wiperblades	<b>OK</b>

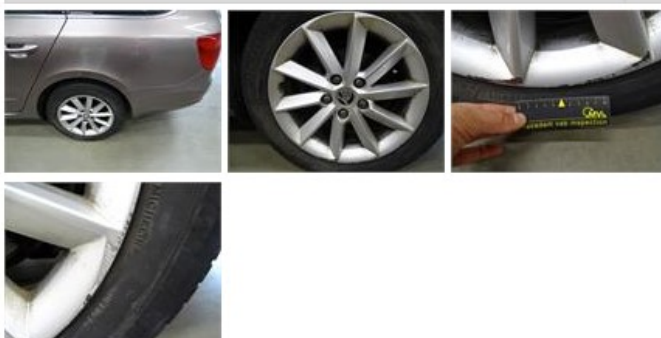
Assistance equipment			
Repair kit	<b>Yes</b>	Compressor	<b>Yes</b>
Total cost ex VAT			<b>1390,16</b>
Alloy rim R L, Scratch(es), LI - Repair and paint (complete)			<b>95,00</b>

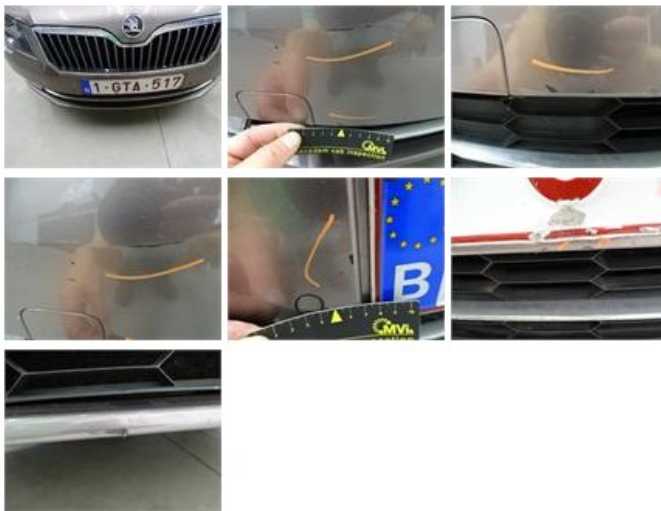
Front bumper, Scratch(es), LI - Repair and paint (complete)			<b>254,16</b>
---	--	--	---------------

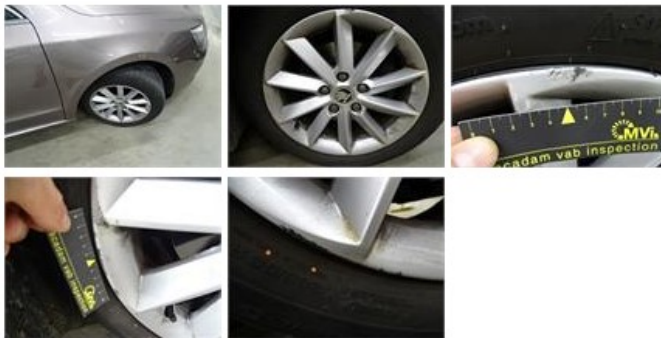
Alloy rim F R, Scratch(es), LI - Repair and paint (complete) 95,00

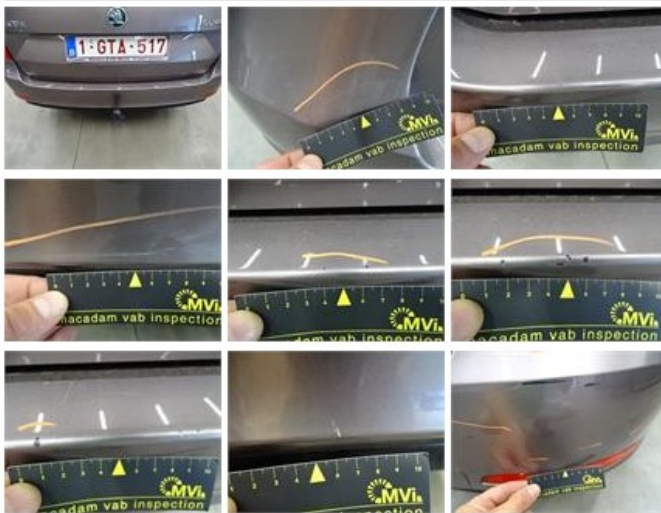
Bumper R, Scratch(es), LI - Repair and paint (complete) 254,16

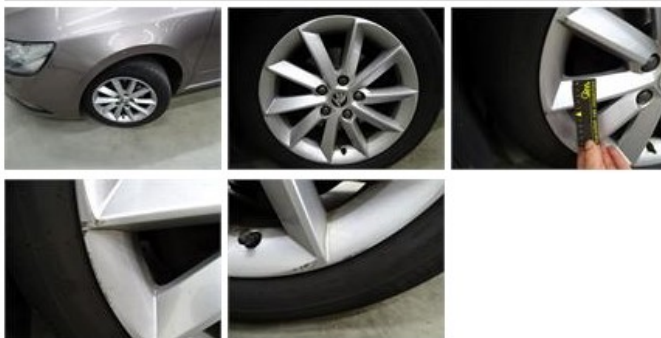
Alloy rim F L, Scratch(es), LI - Repair and paint (complete) 95,00
