**TOYOTA Yaris: 1HAB054**

**Limited Technical Inspection**

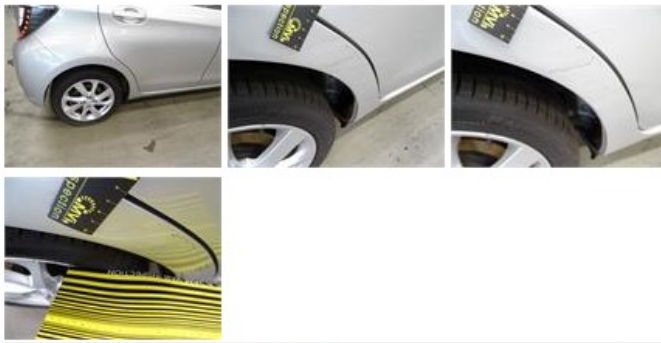
Wing R R, Bump(s) and scratch(es), LI - Repair and paint (complete)	246,56
---------------------------------------------------------------------	--------
