## VOLVO V40: VM5698

## Limited Technical Inspection

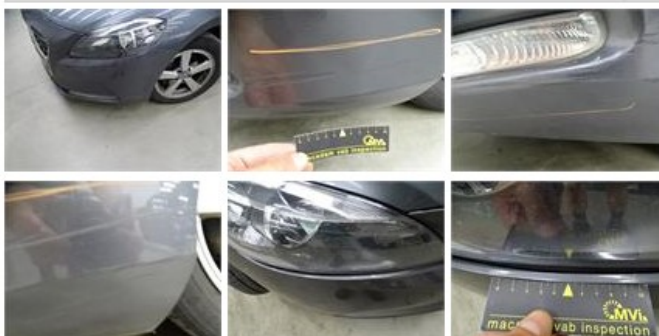
Front bumper, Scratch(es), LI - Repair and paint (complete)	211,80
---	--------
