VOLKSWAGEN Sharan: 1HAB358			
Vinnumber:	WVWZZZ7NZEV040995	Versionname:	SHARAN Comfortline BMT 136PK
First Registrationdate:	2/06/2014	Fiscalpower:	
Expertise Mileage:	78584	Power Kw:	100
Bodytype:	MPV	Body color:	Dark Blue
Gearbox:	MAN 6 VIT	Paint type:	Metalic
Transmission:		Rims summer:	Aluminium
Fueltype:	Diesel	Oil level:	OK
Battery functioning:	Yes	Parking lot:	2223
Number of doors:	5		
Number of seats:	7		
Number head rests:	7		
Rims summer:	Aluminium		
Category:	Passenger Car		
Oil level:	OK		
Registration Certificate Car (BE):	Yes

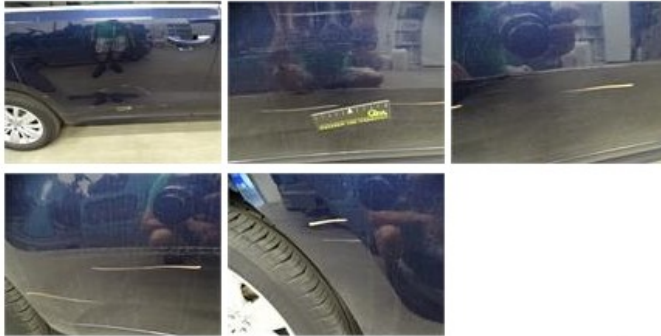
Door R R, Bump(s) and scratch(es), LI - Repair and paint (complete) 382,02

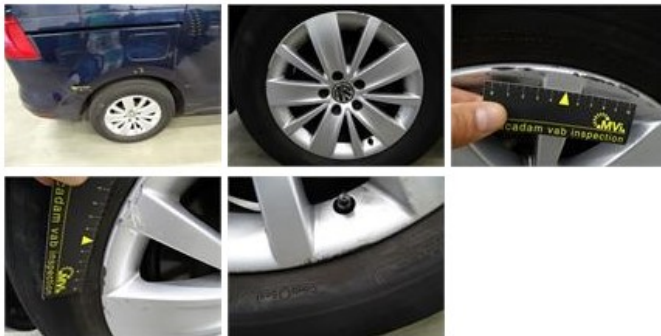
Alloy rim R R, Scratch(es), LI - Repair and paint (complete) 95,00

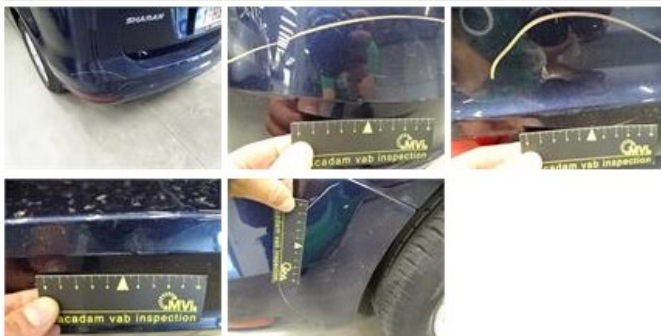
Bumper R, Scratch(es), LI - Repair and paint (complete) 254,16
