**BMW 3: 1HDH330**

**Limited Technical Inspection**

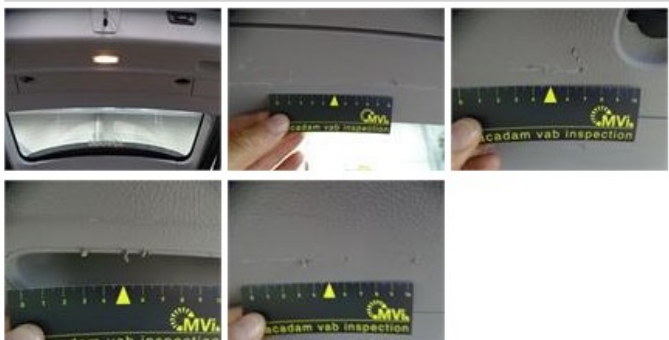
Repair kit	<b>Yes</b>	Compressor	<b>Yes</b>
Total cost ex VAT			417,44
Trunk lid covering R, Scratch(es), Smart repair			110,64

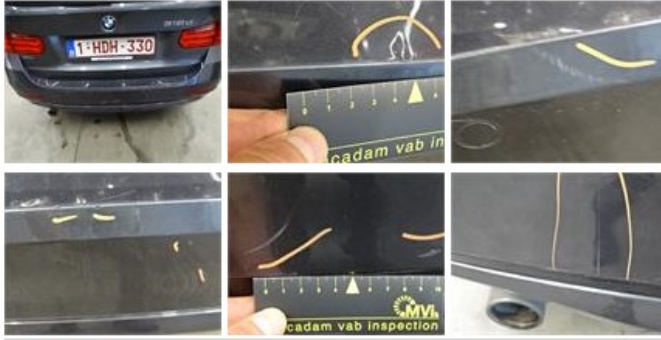
Bumper R, Bump(s) and scratch(es), LI - Repair and paint (complete) 211,80
