**FORD B-Max: 1EJR760**

**Limited Technical Inspection**

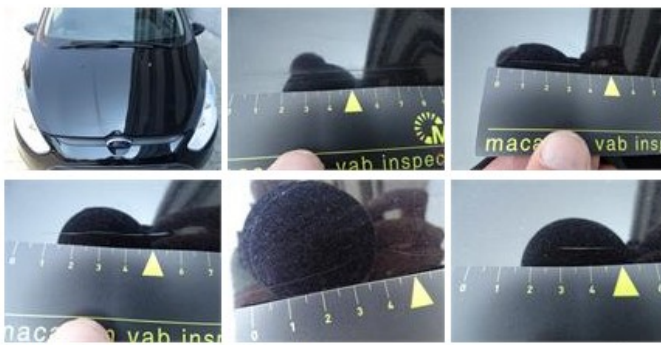
Bonnet, Scratch(es), LI - Repair and paint (complete)	232,06
---	--------

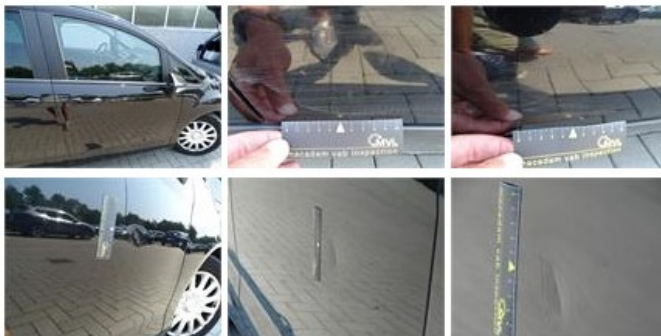
Door F R, Bump(s) and scratch(es), LI - Repair and paint (complete) 254,68

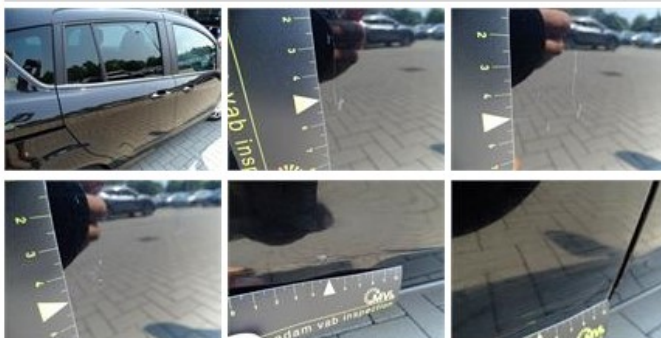
Door R R, Scratch(es), LI - Repair and paint (complete) 254,68
