MERCEDES A: 1JLR517

| Vinnumber: | WDD1760121V048705 | Versionname: | A 180CDI BE Edition 109PK |

Limited Technical Inspection

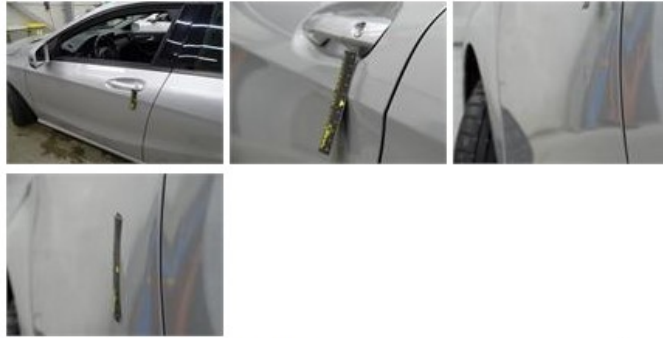
Door F L, Bump(s), PDR - Knock out without painting 82,80

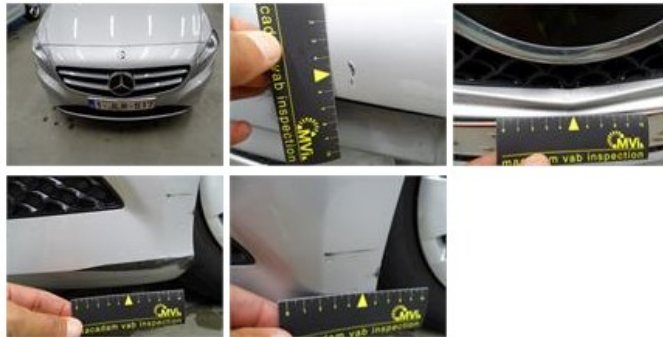
Front bumper, Scratch(es), LI - Repair and paint (complete) 211,80

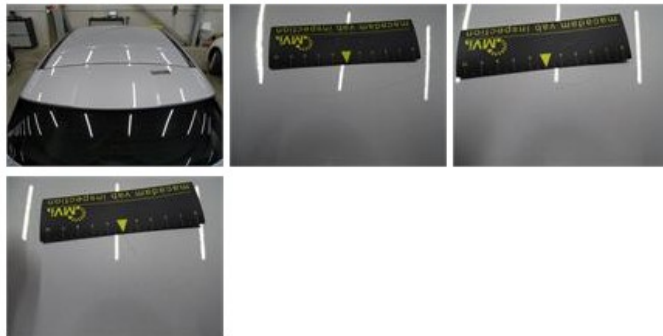
Rear spoiler, Scratch(es), LI - Repair and paint (complete) 115,56
