VOLVO XC60: 1DEZ730			
Vinnnumber:	YV1DZ88A1C2325195	Versionname:	XC60 DRIVe Kinetic St/St
First Registrationdate:	26/04/2012	Fiscalpower:	163PK
Expertise Mileage:	116677	Power Kw:	120
Bodytype:	SUV	Body color:	Beige
Gearbox:	MAN 6 VIT	Paint type:	Metalic
Transmission:		Rims summer:	Aluminium
Fueltype:	Diesel	Oil level:	OK
Battery functioning:	Yes	Parking lot:	2615
Number of doors:	5		
Number of seats:	5		
Number head rests:	5		
Rims summer:	Aluminium		
Category:	Passenger Car		
Oil level:	OK

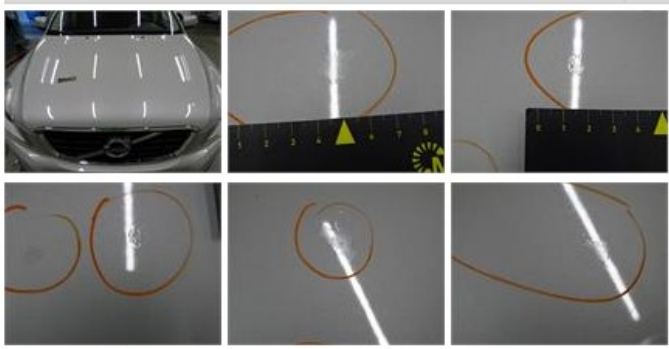
Total cost ex VAT	1644,89
Bonnet, Chemical polution, LI - Repair and paint (complete)	348,09

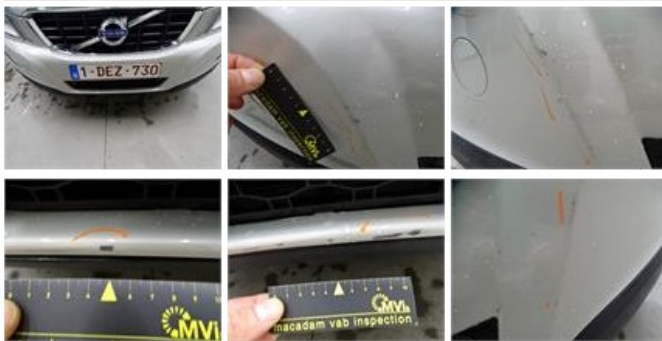
Front bumper, Scratch(es), LI - Repair and paint (complete) 254,16

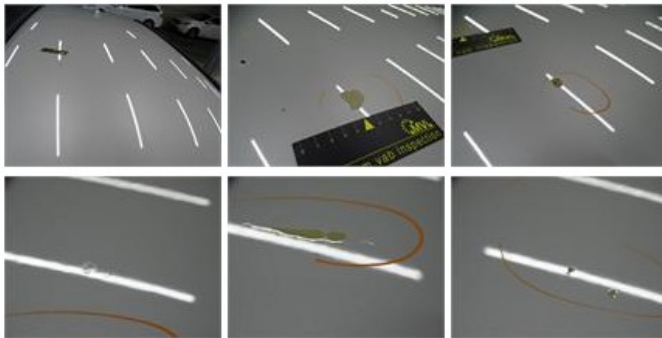
Roof, Chemical pollution, LI - Repair and paint (complete) 577,80
