VOLVO V70: 1FJO200

Limited Technical Inspection

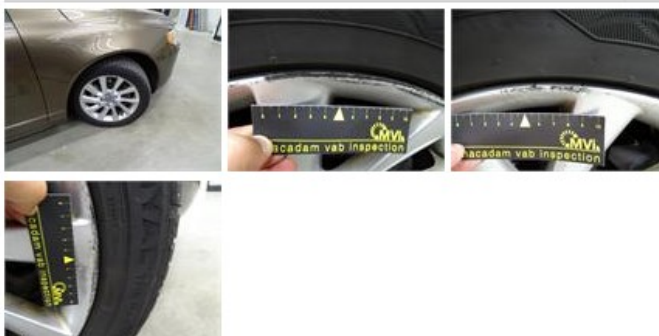
Alloy rim F R, Scratch(es), LI - Repair and paint (complete) 95,00
