**LAND ROVER Evoque: 1EH0986**

**Limited Technical Inspection**

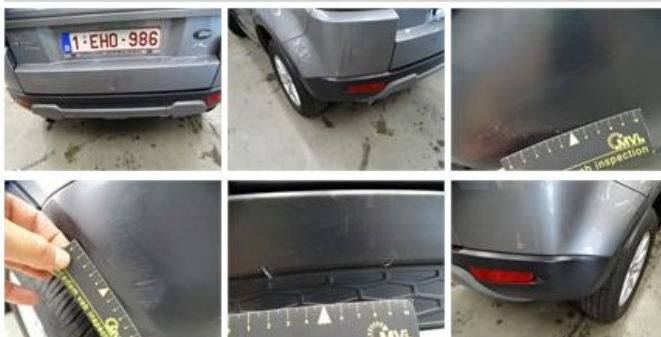
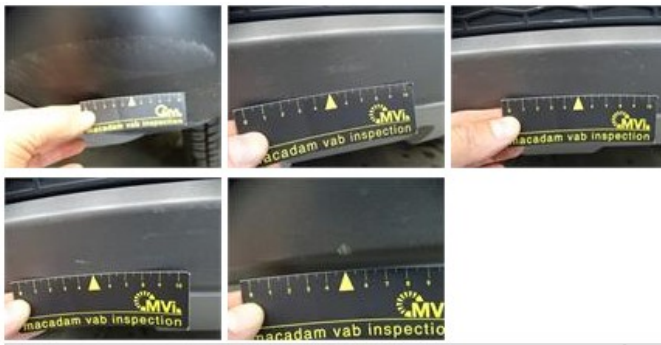
Total cost ex VAT	226,20
Outer door handle F L, Scratch(es), Acceptable	0,00
<i>No pictures to display</i>	
Bumper R, Scratch(es), Smart repair	110,64

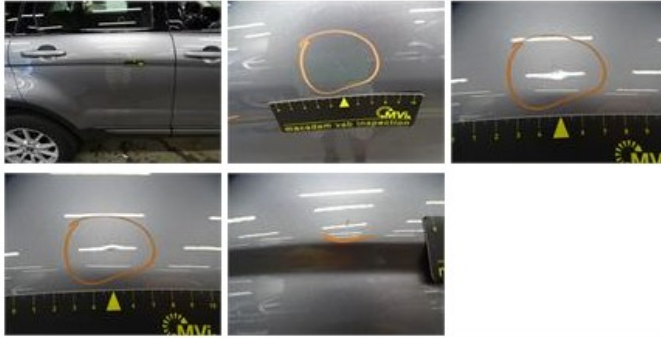
Door R R, Bump(s) and scratch(es), LI - Repair and paint (complete) 0,00
