PEUGEOT 2008: 1GWH576

Limited Technical Inspection

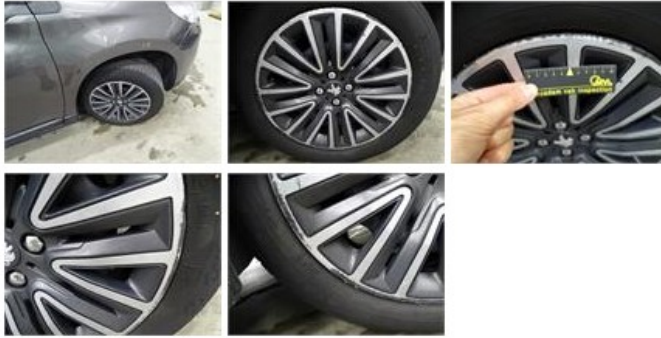
Wheel cover F R, Damaged, E - Replace 30,00

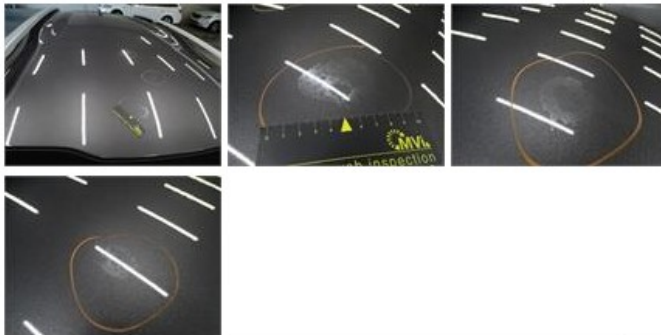
Roof, Chemical polution, LI - Repair and paint (complete) 481,50
