| AUDI A5: 1HLK957 | | | |
| Vinnumber: | WAUZZZ8TXFA010955 | Versionname: | A5 SB Ultra 136PK |

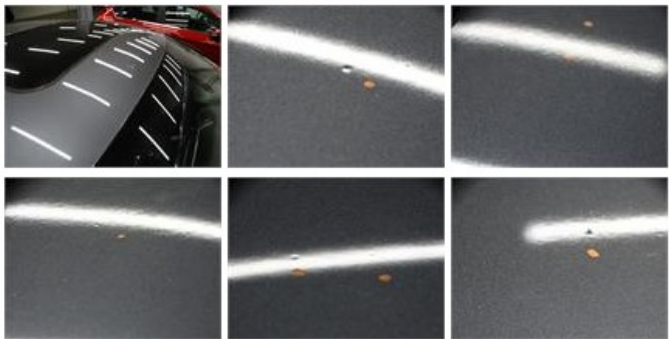
| Roof, Bad repair, Acceptable | 0,00 |

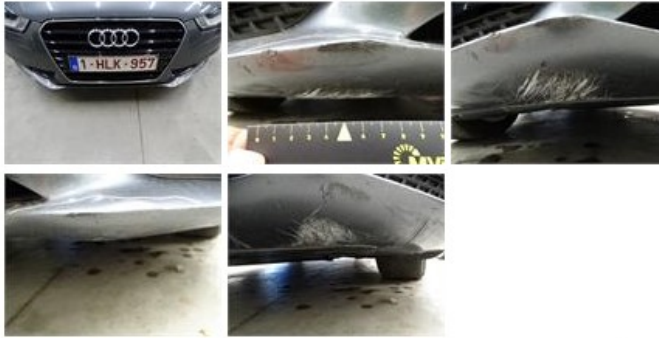
Front bumper, Bump(s) and scratch(es), LI - Repair and paint (complete)

254,16
