BMW 5: 1GWX956

Limited Technical Inspection

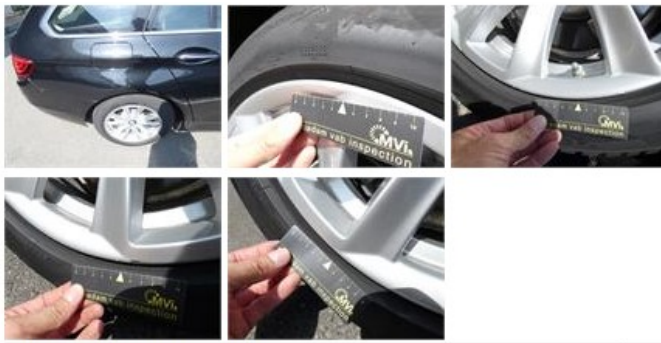
Alloy rim R R, Scratch(es), LI - Repair and paint (complete)	95,00
--	--------------

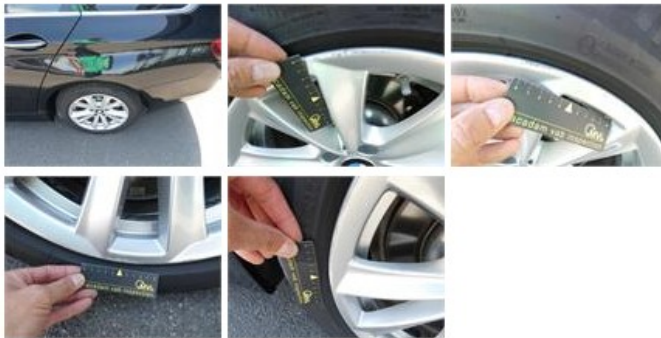
Alloy rim R L, Scratch(es), LI - Repair and paint (complete) 95,00

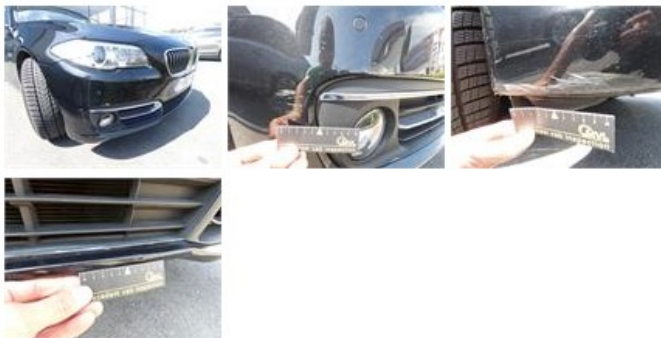
Front bumper, Scratch(es), LI - Repair and paint (complete) 254,16
