MERCEDES E: 1FIQ667			
Vinnumber:	<b>WDD2120051A839720</b>	Versionname:	<b>E BER 200CDI BE 136PK</b>
First Registrationdate:	<b>9/07/2013</b>	Fiscalpower:	
Expertise Mileage:	<b>116549</b>	Power Kw:	<b>100</b>
Bodytype:		Body color:	<b>Grey</b>
Gearbox:	<b>Automatic</b>	Paint type:	<b>Metalic</b>
Transmission:	<b>Back</b>	Rims summer:	<b>Aluminium</b>
Fueltype:	<b>Diesel</b>	Oil level:	<b>OK</b>
Battery functioning:	<b>Yes</b>	Parking lot:	<b>1432</b>
Number of doors:	<b>4</b>		
Number of seats:	<b>5</b>		
Number head rests:	<b>5</b>		
Rims summer:	<b>Aluminium</b>		
Category:	<b>Passenger Car</b>		
Oil level:	<b>OK</b>		
Registration Certificate Car (BE):	<b>Yes</b>

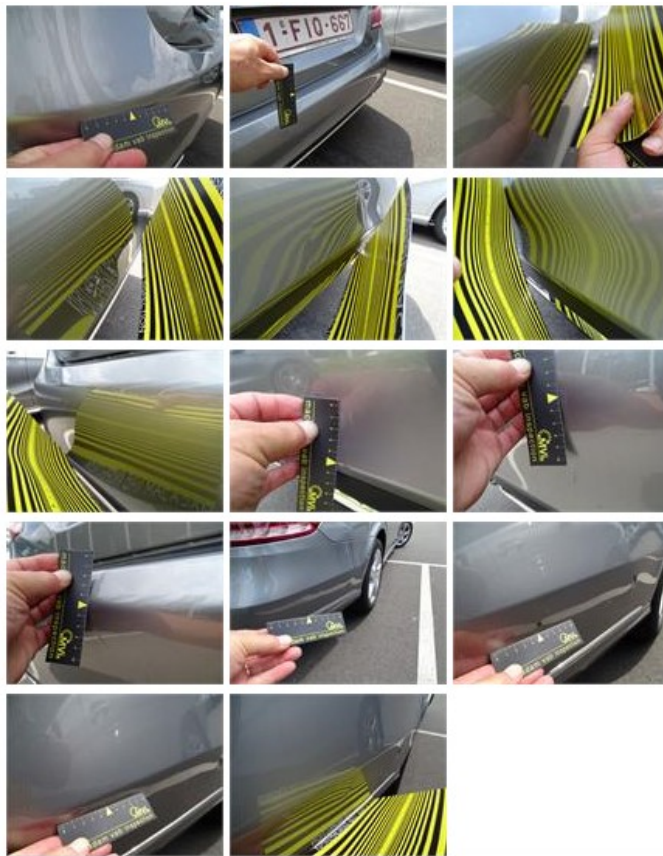
Total cost ex VAT	349,16
Bumper R, Bump(s) and scratch(es), LI - Repair and paint (complete)	254,16

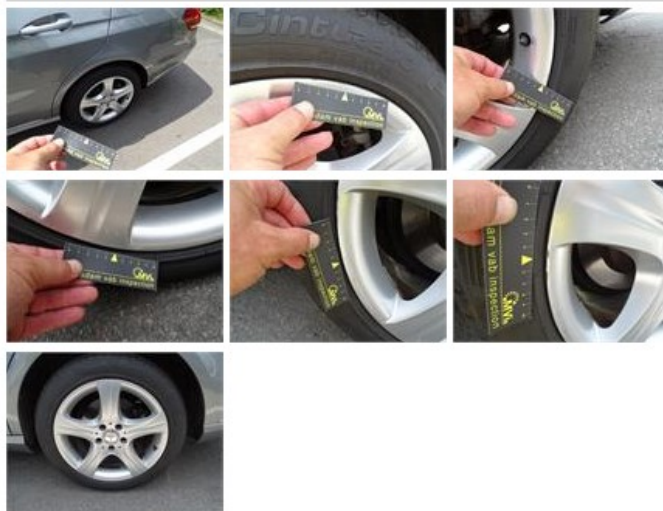
Rocker panel inner R L, Scratch(es), Acceptable	0,00
<i>No pictures to display</i>	
Door F L, Bump(s), Acceptable	0,00
<i>No pictures to display</i>	
Front bumper, Scratch(es), Acceptable	0,00
<i>No pictures to display</i>	
Roof, Bump(s), Acceptable	0,00
<i>No pictures to display</i>	
Door F R, Scratch(es), Acceptable	0,00
<i>No pictures to display</i>	
Wing R L, Bump(s), Acceptable	0,00
<i>No pictures to display</i>	
Alloy rim F L, Scratch(es), Acceptable	0,00
