MERCEDES A: 1EZG590

Limited Technical Inspection

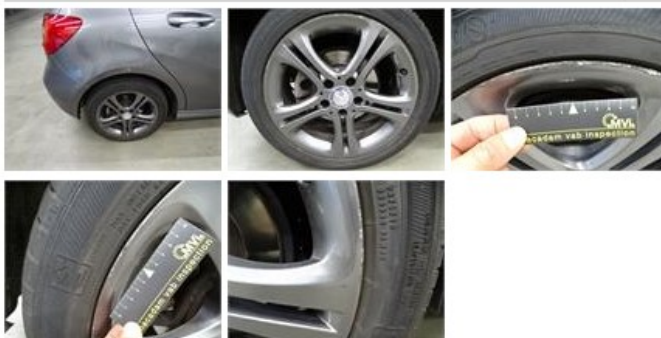
Alloy rim R R, Scratch(es), LI - Repair and paint (complete)	95,00
--	--------------

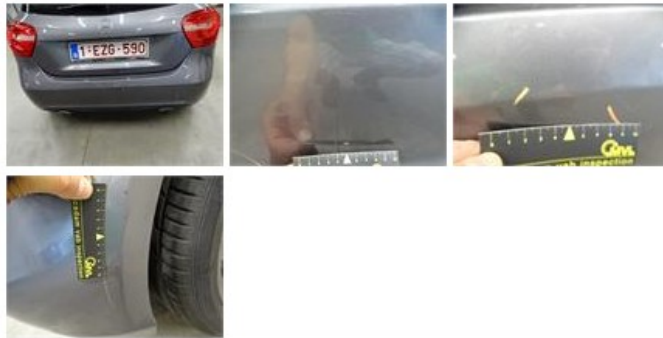
Bumper R, Scratch(es), LI - Repair and paint (complete) 211,80

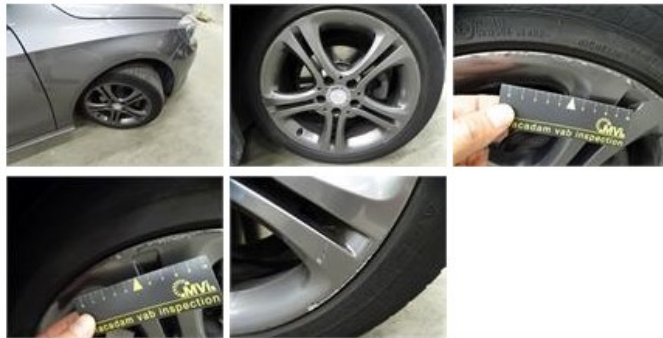
Alloy rim F R, Scratch(es), LI - Repair and paint (complete) 95,00

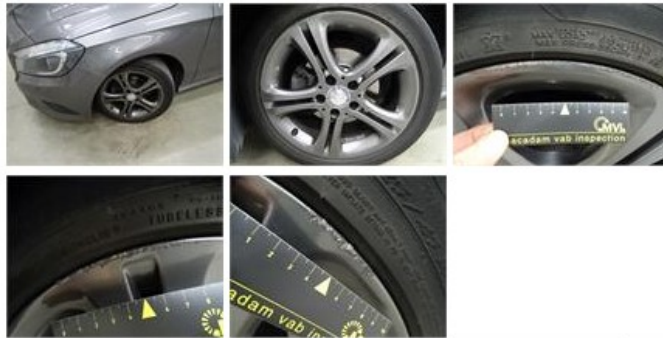
Alloy rim F L, Scratch(es), LI - Repair and paint (complete) 95,00
