MAZDA CX-5: 1FKI293			
Vinnnumber:	JMZKEF91600224081	Versionname:	CX-5 4x2 Active 150PK
First Registrationdate:	25/07/2013	Fiscalpower:	
Expertise Mileage:	147157	Power Kw:	110
Bodytype:	SUV	Body color:	Dark Grey
Gearbox:	MAN 6 VIT	Paint type:	Metalic
Transmission:		Rims summer:	Aluminium
Fueltype:	Diesel	Oil level:	OK
Battery functioning:	Yes	Parking lot:	2820
Number of doors:	5		
Number of seats:	5		
Number head rests:	5		
Rims summer:	Aluminium		
Category:	Passenger Car		
Oil level:	OK

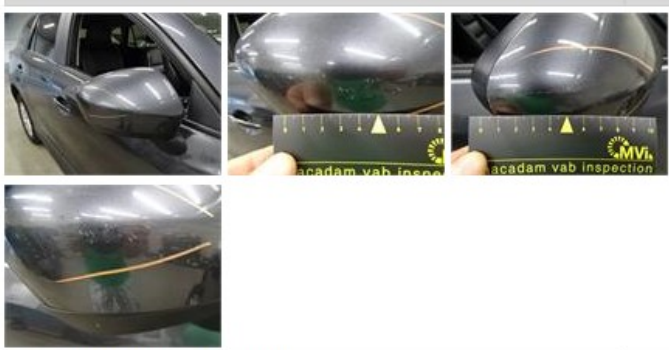
Assistance equipment			
Repair kit	Yes	Compressor	Yes
Total cost ex VAT			1327,41
Rearview mirror housing R, Scratch(es), LI - Repair and paint (complete)			115,56
