<b>MERCEDES A: 1FDR649</b>			
Vinnnumber:	<b>WDD1760121J118711</b>	Versionname:	<b>A 180 CDI BE 109PK</b>
First Registrationdate:	<b>3/06/2013</b>	Fiscalpower:	
Expertise Mileage:	<b>157053</b>	Power Kw:	<b>80</b>
Bodytype:		Body color:	<b>White</b>
Gearbox:	<b>MAN 6 VIT</b>	Paint type:	<b>Metalic</b>
Transmission:		Rims summer:	<b>Aluminium</b>
Fueltype:	<b>Diesel</b>	Oil level:	<b>OK</b>
Battery functioning:	<b>Yes</b>	Parking lot:	<b>2604</b>
Number of doors:	<b>5</b>		
Number of seats:	<b>5</b>		
Number head rests:	<b>5</b>		
Rims summer:	<b>Aluminium</b>		
Category:	<b>Passenger Car</b>		
Oil level:	<b>OK</b>

<b>Limited Technical Inspection</b>			
Airco functioning	<b>OK</b>	Battery functioning	<b>Yes</b>
Tires wear profile	<b>OK</b>	Power steering	<b>Yes</b>
Idle position	<b>OK</b>	Sound engine	<b>OK</b>
Engine startingtime	<b>OK</b>	Clutch test	<b>OK</b>
Exhaust gass	<b>OK</b>	Wiper fluid level	<b>OK</b>
Handbrake	<b>OK</b>	Transmission	<b>OK</b>
		Lighting	<b>OK</b>
		Wiperblades	<b>OK</b>

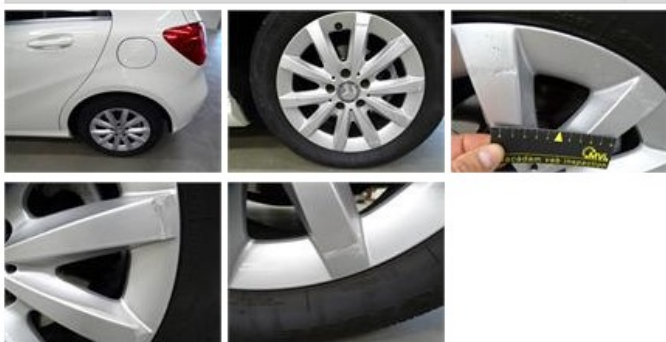
<b>Assistance equipment</b>			
Repair kit	<b>Yes</b>	Compressor	<b>Yes</b>
<b>Total cost ex VAT</b>			<b>805,00</b>
<b>Alloy rim R L, Damaged, LI - Repair and paint (complete)</b>			<b>95,00</b>

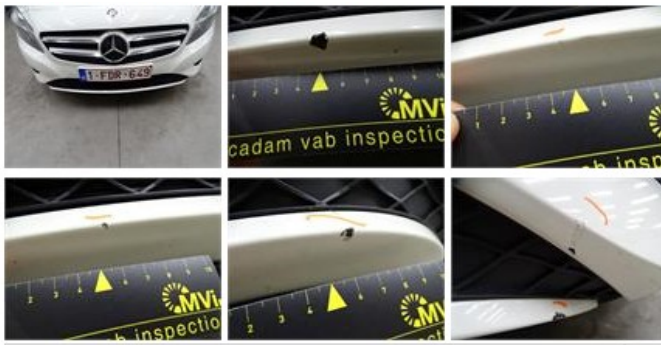
<b>Front bumper, Bump(s) and scratch(es), LI - Repair and paint (complete)</b>	<b>211,80</b>
--	---------------

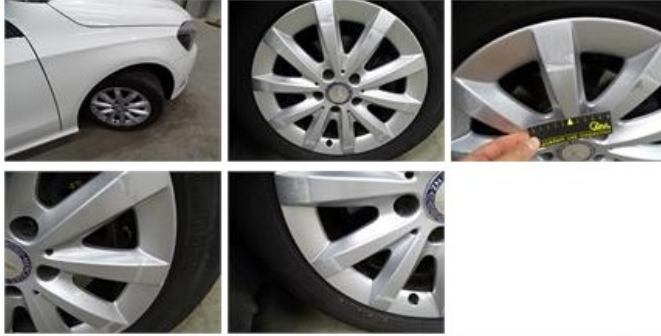
Alloy rim F R, Damaged, LI - Repair and paint (complete) 95,00

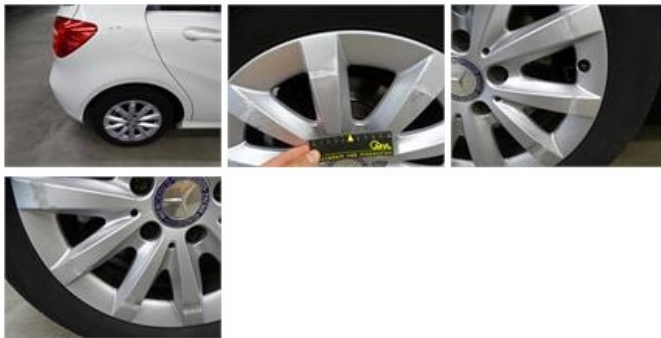
Alloy rim R R, Damaged, LI - Repair and paint (complete) 95,00
