VOLKSWAGEN Golf: 1GTU781

| Vinnnumber: | WVWZZZAUZEP528718 | Versionname: | GOLF VAR Trendline 105PK |

Limited Technical Inspection

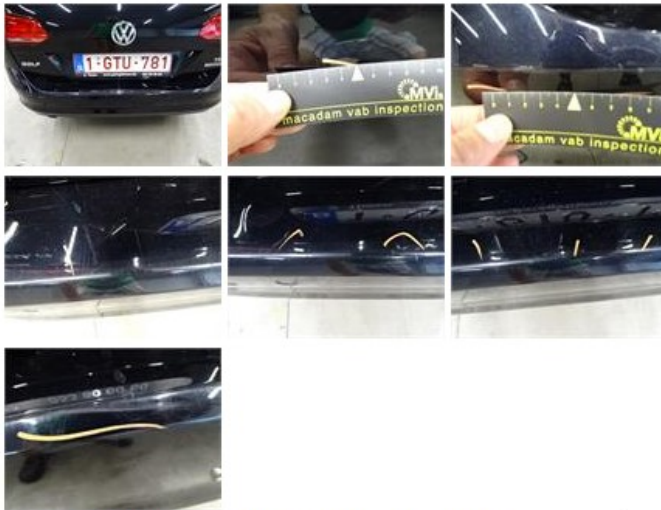
Bumper R, Scratch(es), LI - Repair and paint (complete) 211,80
