SKODA Superb: 1HEJ585

Limited Technical Inspection

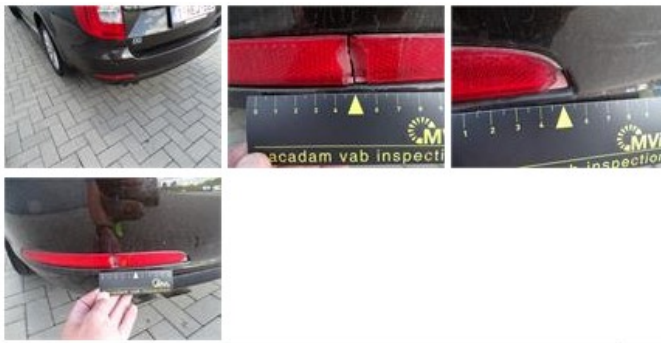
Reflector, Broken, E - Replace	15,00
--------------------------------	--------------

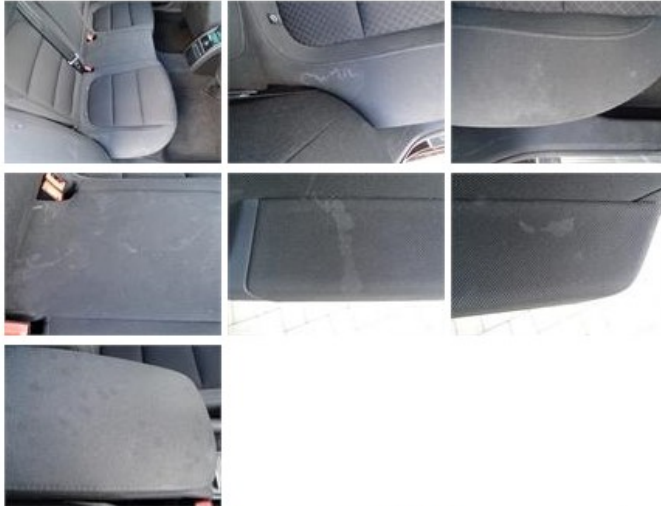
Interior, Stain, Cleaning 25,00

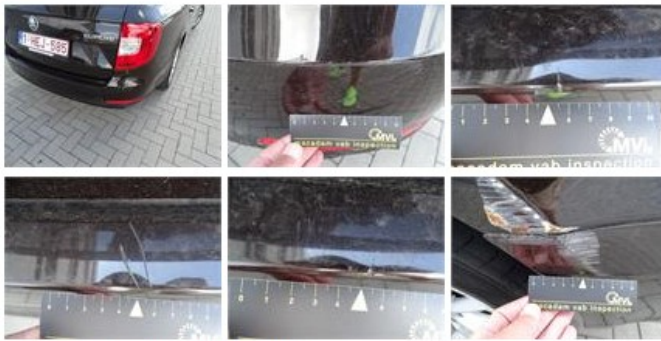
Bumper R, Scratch(es), LI - Repair and paint (complete) 254,16

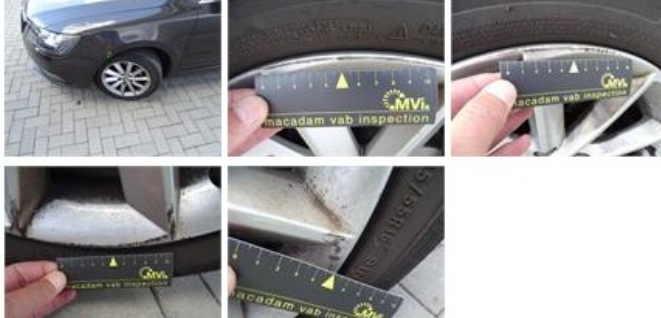
Alloy rim F L, Scratch(es), LI - Repair and paint (complete) 95,00
