**TOYOTA AURIS: 1PHN986**

**Limited Technical Inspection**

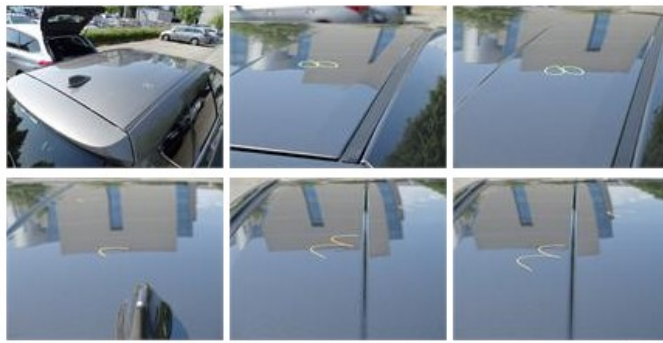
Roof, Hail damage, PDR - Hail	<b>750,00</b>
-------------------------------	---------------

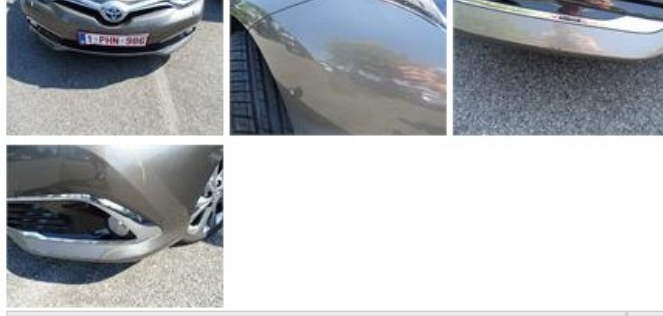
Front bumper, Scratch(es), LI - Repair and paint (complete) 211,80

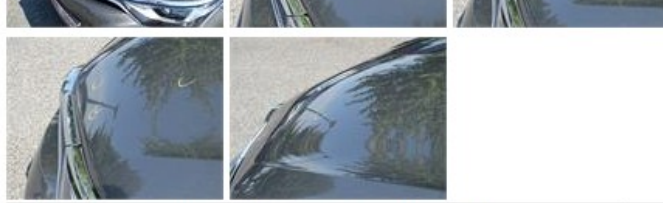
Bonnet, Hail damage, PDR - Hail 250,00
