## VOLVO XC60: 1HAZ058

## Limited Technical Inspection

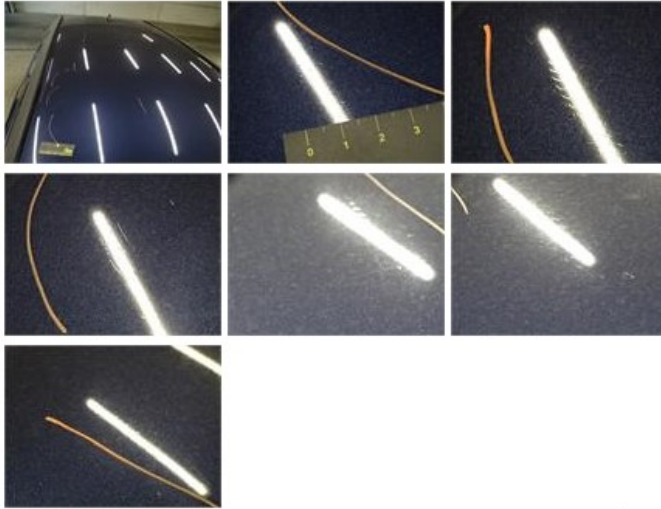
Roof, Bad repair, Acceptable 0,00

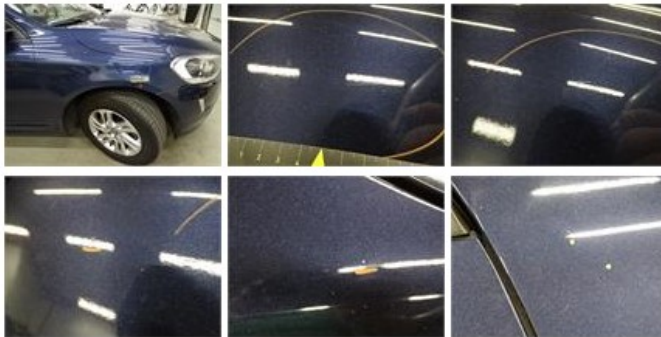
Wing F R, Bad repair, Acceptable 0,00

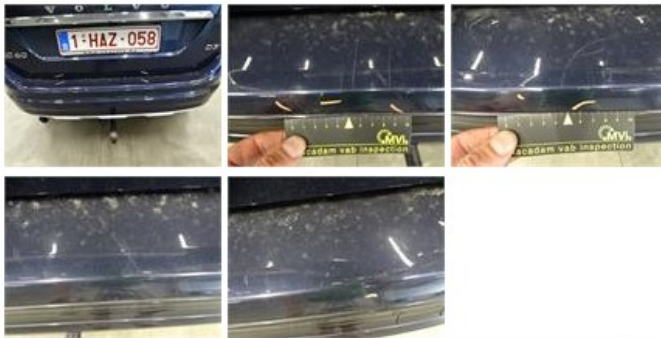
Bumper R, Scratch(es), LI - Repair and paint (complete) 254,16
