## VOLVO V70: 1EUG816

Vinnumber:	<b>YV1BW31A1D1272577</b>	Versionname:	<b>V70 D3 Kinetic St/St</b>
First Registrationdate:	<b>22/03/2013</b>	Fiscalpower:	<b>136PK</b>
Expertise Mileage:	<b>145807</b>	Power Kw:	<b>100</b>
Bodytype:		Body color	<b>Black</b>
Gearbox:	<b>MAN 6 VIT</b>	Paint type	<b>Metalic</b>
Transmission:	<b>Front</b>	Rims summer	<b>Aluminium</b>
Fueltype:	<b>Diesel</b>	Oil level	<b>OK</b>
Maintenance	<b>OK</b>	Parking lot	<b>1428</b>
Battery functioning	<b>Yes</b>		
Number of doors	<b>5</b>		
Number of seats	<b>5</b>		
Number head rests	<b>5</b>		
Rims summer	<b>Aluminium</b>		
Category	<b>Passenger Car</b>		
Oil level	<b>OK</b>

## Limited Technical Inspection

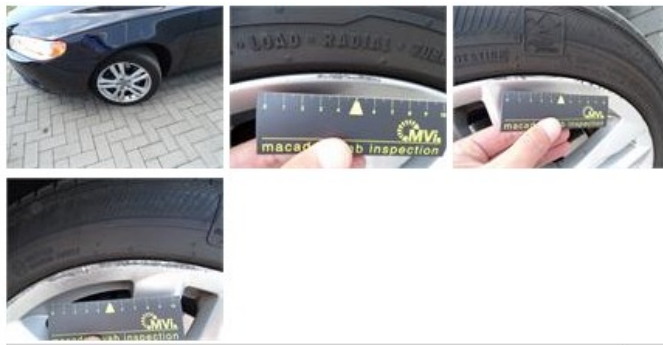
Alloy rim F L, Scratch(es), LI - Repair and paint (complete) 95,00

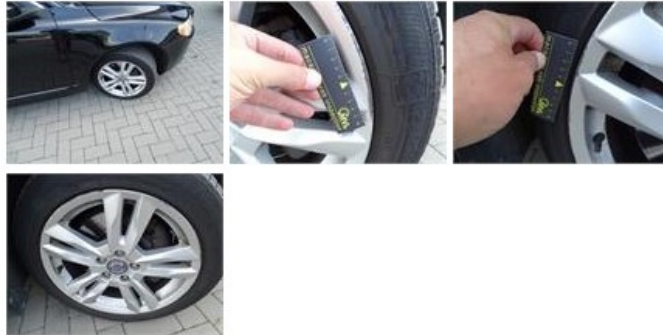
Alloy rim F R, Scratch(es), LI - Repair and paint (complete) 95,00

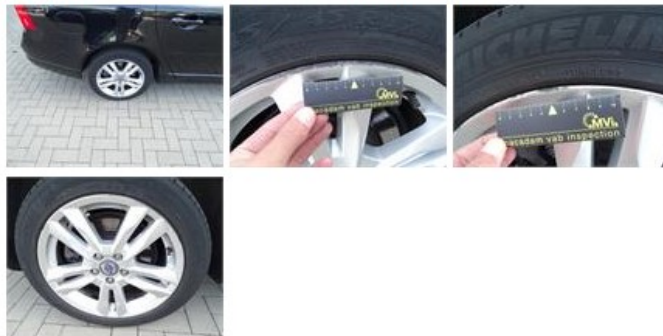
Alloy rim R R, Scratch(es), LI - Repair and paint (complete) 95,00

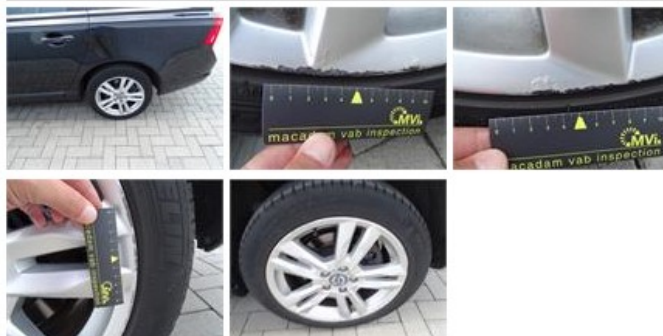
Alloy rim R L, Scratch(es), LI - Repair and paint (complete) 95,00

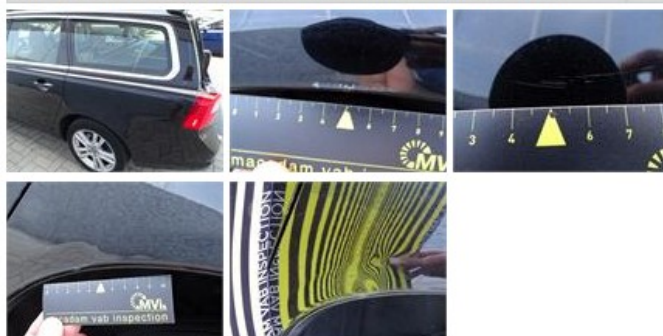
Wing R L, Bump(s) and scratch(es), LI - Repair and paint (complete) 369,84
