VOLVO V40: 1GWV715

Limited Technical Inspection

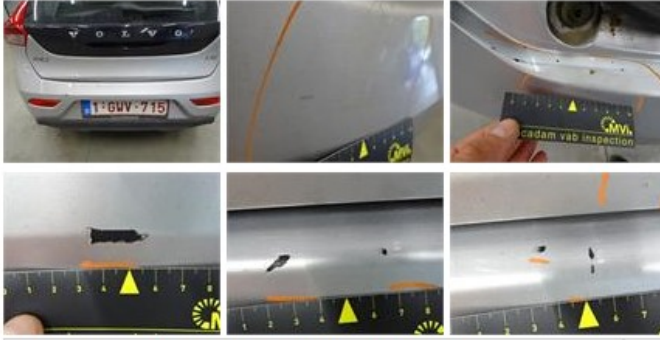
Bumper R, Scratch(es), LI - Repair and paint (complete) 211,80

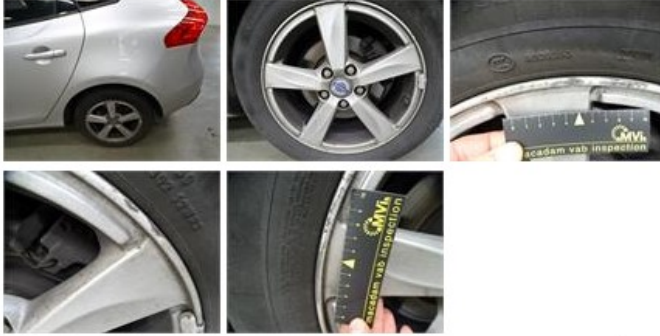
Alloy rim R L, Scratch(es), LI - Repair and paint (complete) 95,00

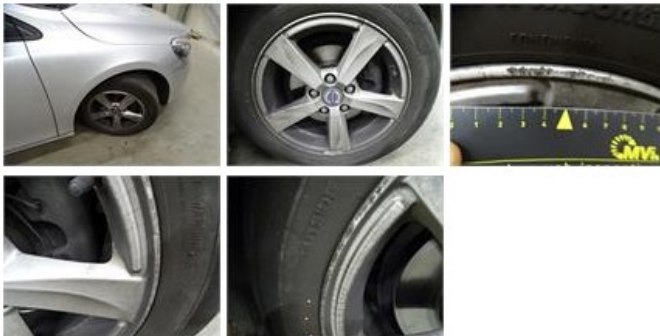
Alloy rim F R, Scratch(es), LI - Repair and paint (complete) 95,00

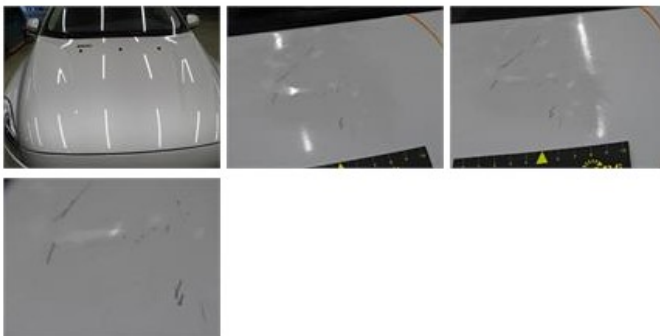
Bonnet, Scratch(es), LI - Repair and paint (complete) 290,08
