## VOLKSWAGEN Touran: 1ESV137

## Limited Technical Inspection

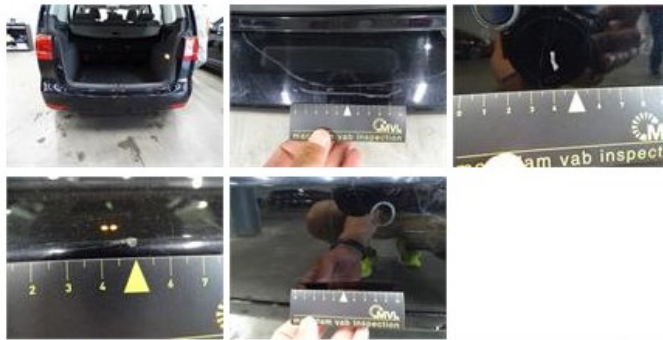
Bumper R, Scratch(es), LI - Repair and paint (complete) 211,80

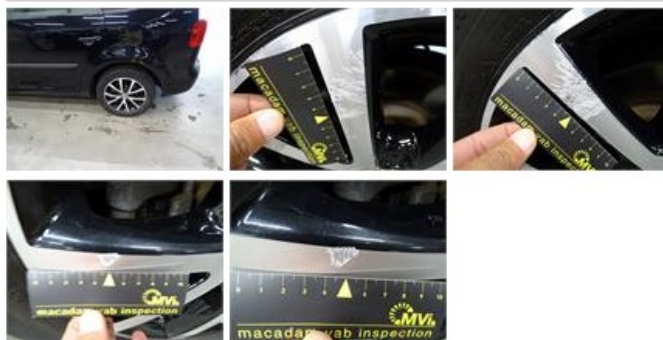
Alloy rim R L polished, Damaged, E - Replace 235,20

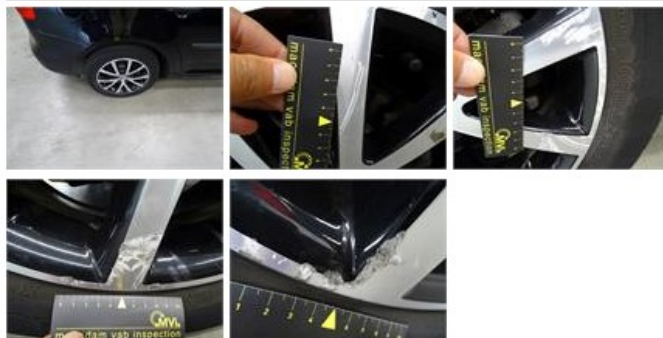
Alloy rim R R polished, Damaged, E - Replace 235,20
