VOLVO V60: 1FRG512

Limited Technical Inspection

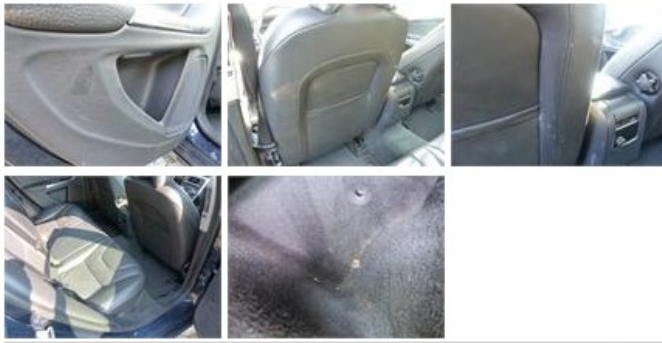
Interior, Dirty, Cleaning 25,00

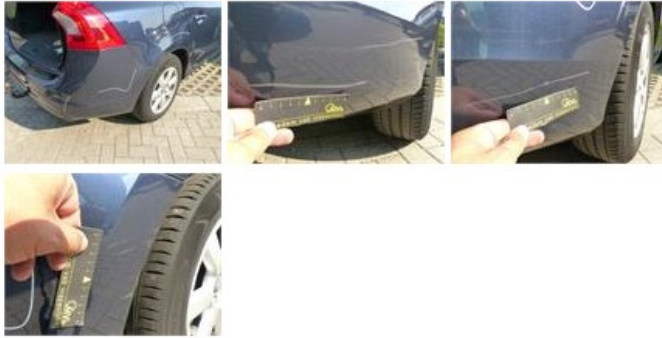
Bumper R, Bump(s) and scratch(es), LI - Repair and paint (complete) 211,80
