FORD Mondeo: 1GTR835

Limited Technical Inspection

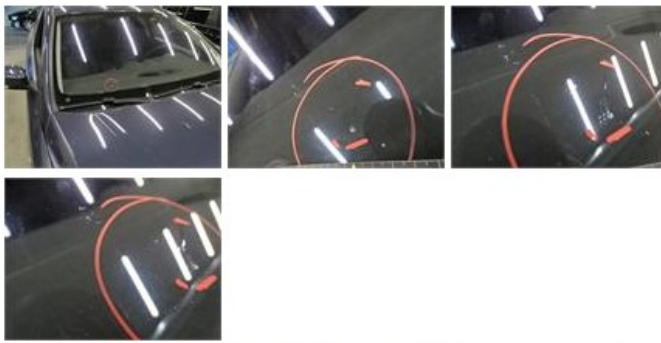
Windscreen, Crack, E - Replace
487,20

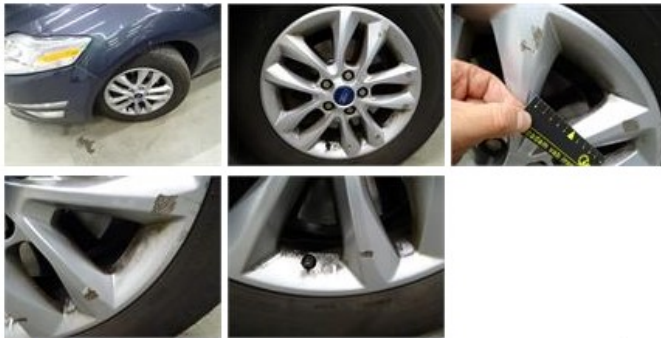
Alloy rim F L, Scratch(es), LI - Repair and paint (complete) 95,00

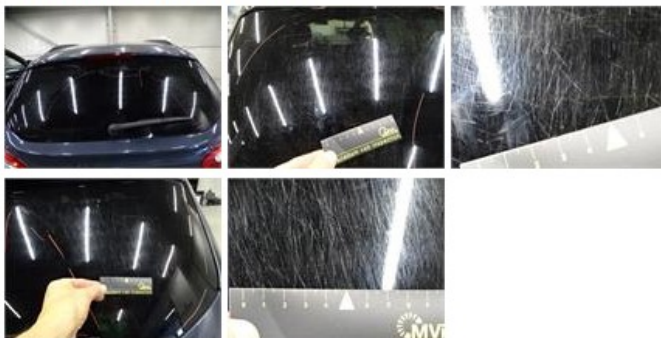
Rear window, Scratch(es), E - Replace 370,00

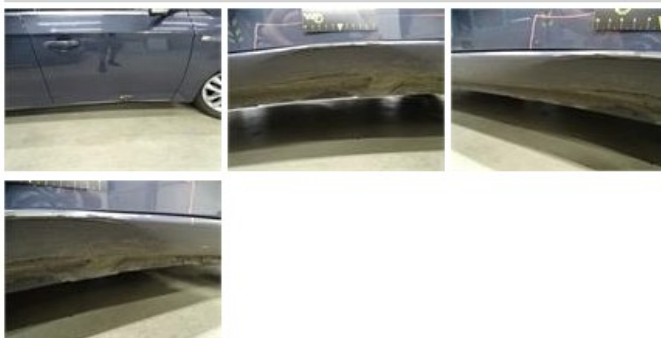
Sill outer R, Dent(s) and scratch(es), LI - Repair and paint (complete) 310,50
