MERCEDES A: 1FIQ661			
Vinnumber:	WDD1760121J132224	Versionname:	A 180 CDI BE 109PK
First Registrationdate:	9/07/2013	Fiscalpower:	
Expertise Mileage:	90460	Power Kw:	80
Bodytype:	Berline	Body color:	.
Gearbox:	MAN 6 VIT	Body color:	Grey
Transmission:	Front	Paint type:	Metalic
Fueltype:	Diesel	Rims summer:	Aluminium
Battery functioning:	Yes	Oil level:	OK
Number of doors:	5	Parking lot:	.1329
Number of seats:	5		
Number head rests:	1		
Rims summer:	Aluminium		
Category:	Passenger Car		
Oil level:	OK

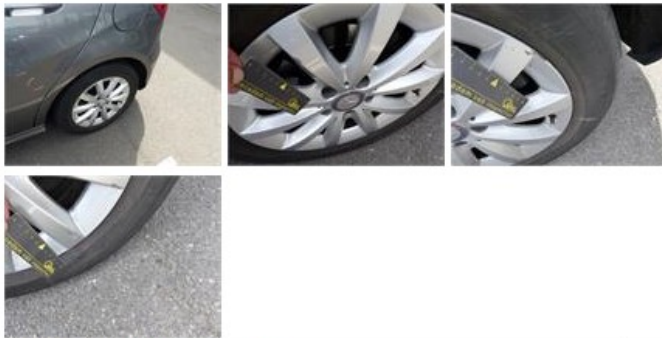
Alloy rim R L, Scratch(es), LI - Repair and paint (complete) 95,00
