OPEL Zafira: 1FLQ778

| Vinnumber: | WOLPE9E35D2104371 | Versionname: | ZAFIRA TOURER |

Limited Technical Inspection

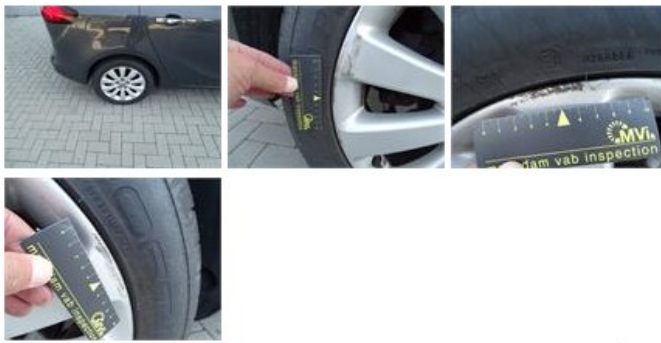
Alloy rim R R, Scratch(es), LI - Repair and paint (complete) **95,00**

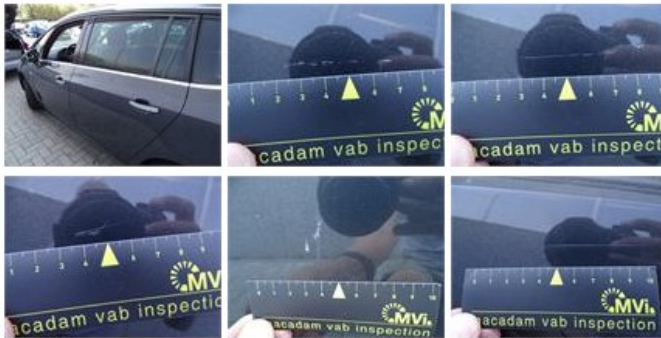
Door R L, Scratch(es), LI - Repair and paint (complete) 318,35
