BMW 318d: 1HLC601

Limited Technical Inspection

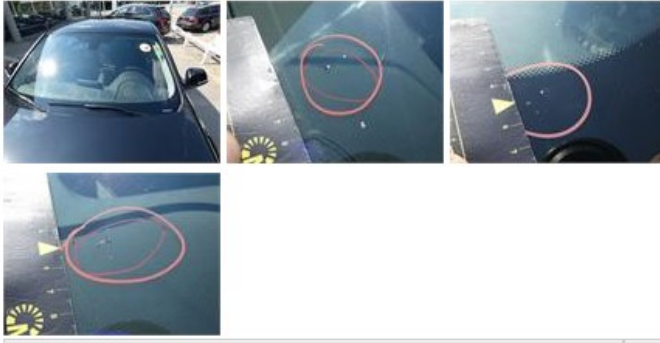
Windscreen, Stone chip(s), E - Replace
